# CR 20 GULLY STABILIZATION

## ROCK LINED CHANNEL

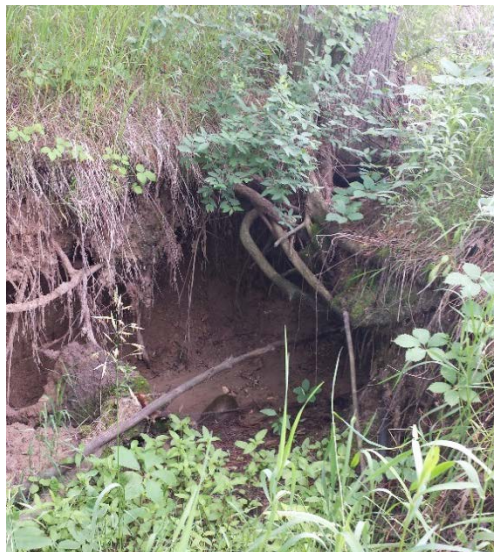
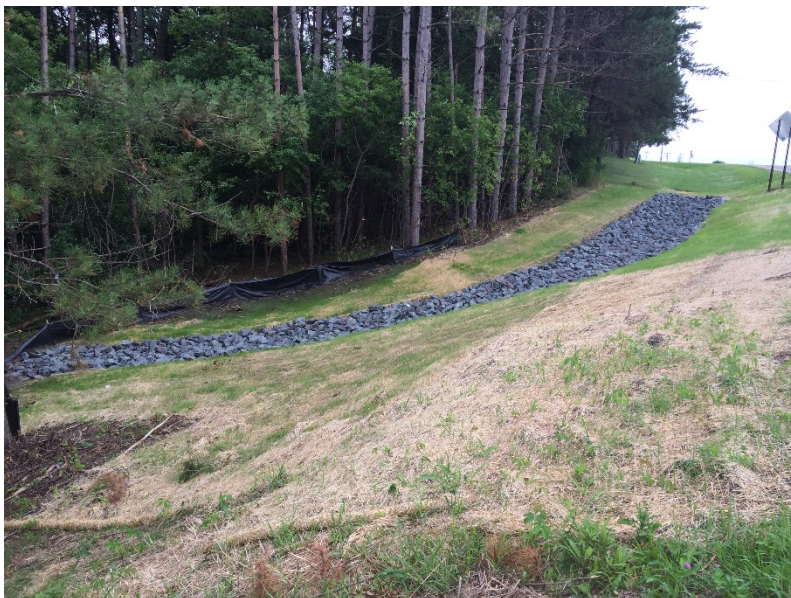
Stormwater runoff within the ditch alongside County Road 20 north of Lindstrom was causing active erosion within a gully. Each time it rained, the gully head was cutting more and washing more sediment down the gully into North Center Lake.

In partnership with the Chisago County Public Works Department, the Chisago SWCD was able to stabilize the gully in the summer of 2015. The gully was re-shaped, lined with a heavy protective fabric, and then lined with rocks. Water can navigate the rock-lined channel without causing erosion of the sediment underneath.

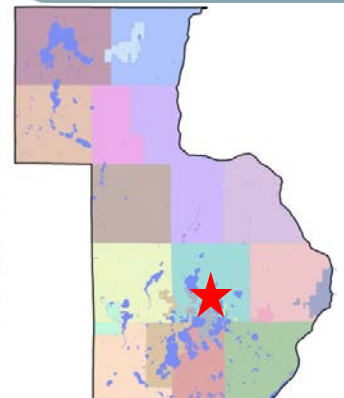
Yes. The project is within the road ditch along County Road 20.
