NELSON COURT GULLY STABILIZATION

CHANNEL STABILIZATION

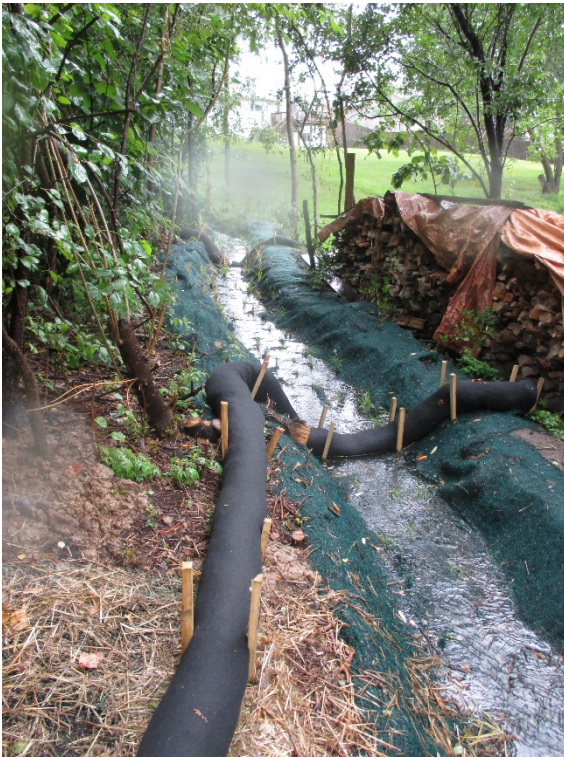
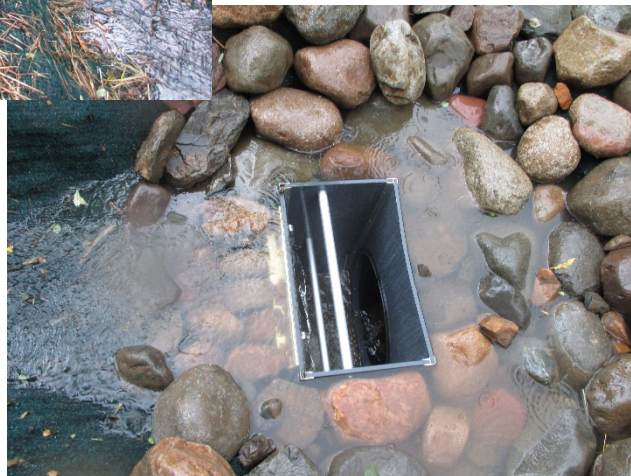
A portion of the residential neighborhood around Nelson Court in Center City drains through roadside ditches into Pioneer Lake. Along the last portion of the ditch system, erosion was occurring within the channel due to the large volume and high velocity of the runoff water traveling through it. The gully was stabilized in 2015. A permanent tough fabric was installed along the bottom and sides of the channel to help keep the soil beneath the blanket in place. Rock checks were installed along the channel to slow water down and allow sediment being carried in the water to drop out before reaching the lake. At the end of the channel, a structure allows the water to make the steep drop to lake level without washing away the bank.
