PAT EICHEN PROJECTS

GRASS WATERWAY & WATER & SEDIMENT CONTROL BASINS

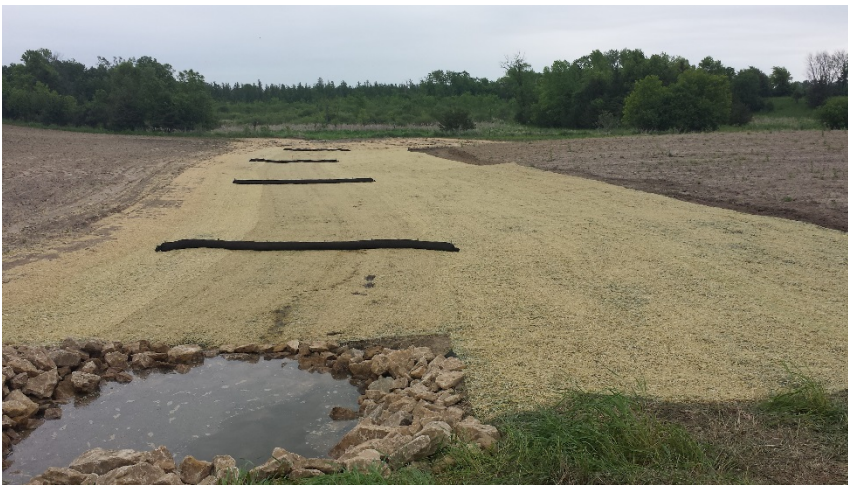
Two stabilization practices were installed at two different locations. In one field, a culvert allowed water to enter the field at a concentrated location, causing erosion across the field as it flowed to an adjacent wetland. At the culvert outlet, a rock bowl was installed to help dissipate energy. A grassed waterway was installed from the culvert to the wetland, giving the water a place to flow that was well protected so that erosion would no longer occur.

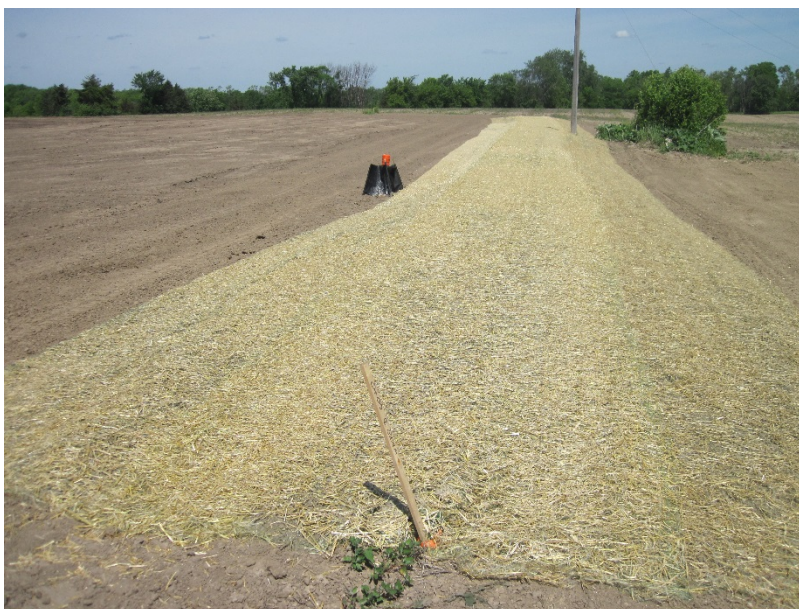
On a second field, a gully had formed as water flowed through the agricultural field. In this case, a water and sediment control basin was installed to temporarily hold back water. A perforated outlet pipe allows the water to slowly drain to a protected outlet location.
