# LINDSTROM BEACH PARK RESTORATION

## SHORELINE RESTORATION

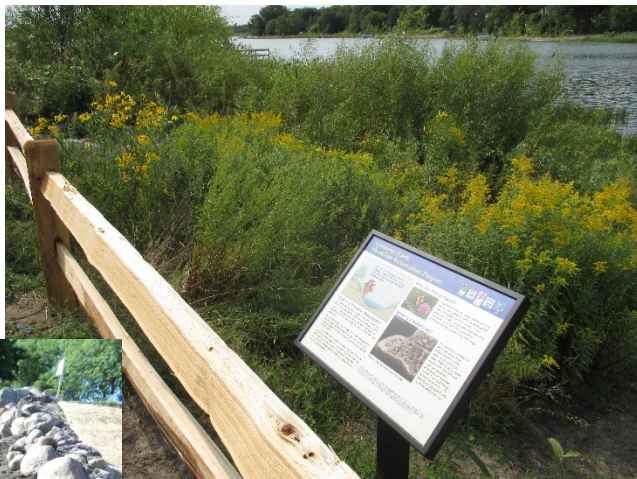
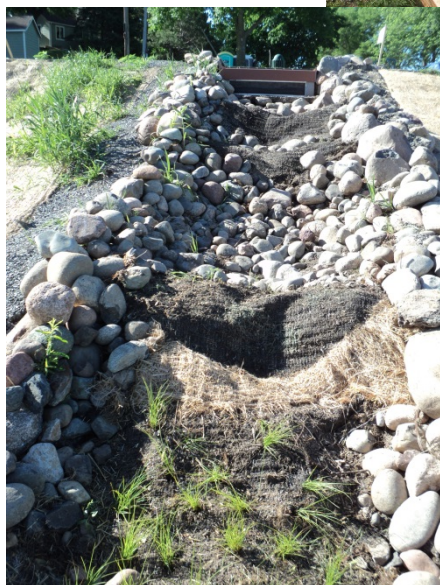
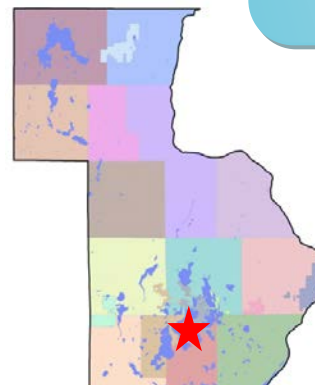
Beach Park is one of Lindstrom's most popular and most used parks. At the park entrance, a steep asphalt road leads to a parking lot right on the water's edge. The parking lot was originally designed with three curb cuts that allow water to drain from the lot directly into the lake, with no treatment. Due to the large drainage area and the high velocity of water traveling through the curb cuts, and the low level of the lakes, small gullies had formed at two of the curb cuts. Chemicals from lawns, the road, and the parking lot all drain directly into South Lindstrom Lake.

In 2013, a restoration of the shoreline along the parking lot was installed to help stabilize the shoreline and reduce the small gullies that were occurring. It will also add aesthetic value to the park when the native wildflowers and grasses mature because the restoration will be an improvement over the weedy bank. In addition, two pretreatment chambers at the curb cuts help remove the large amounts of sediment that come off the parking lot, while helping slow the velocity of water.
