SOUTH CENTER LAKE BOAT LAUNCH

PRETREATMENT AND VEGETATED SWALE

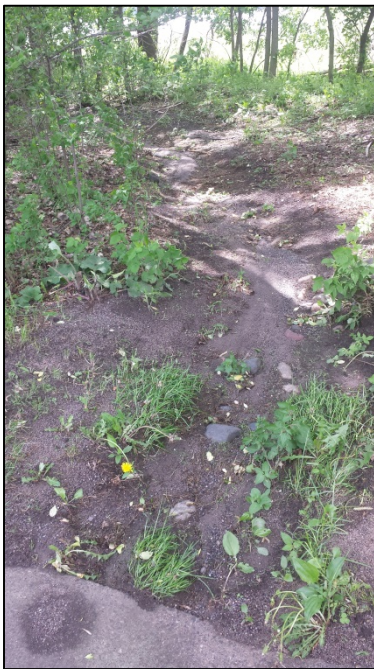
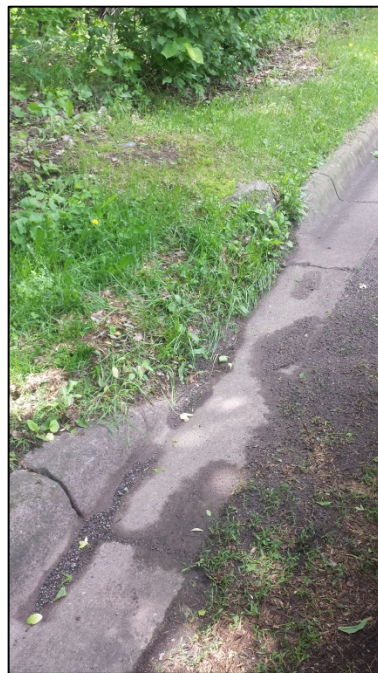
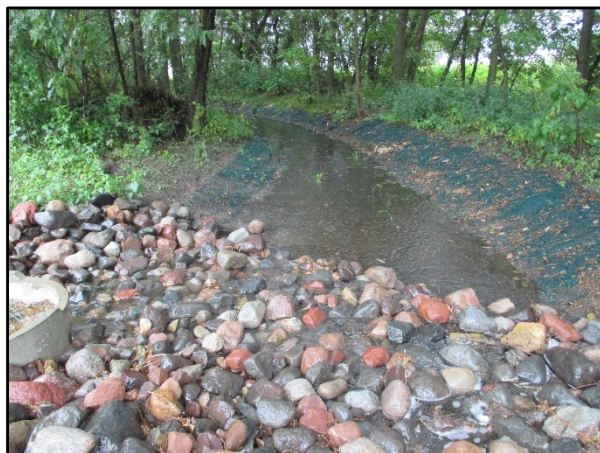
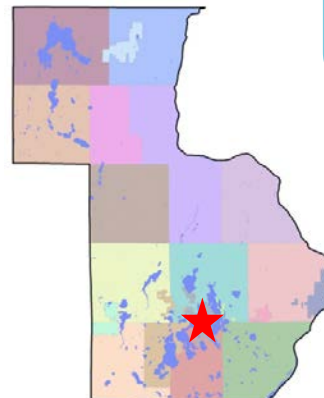
The DNR Public Lake Access to South Center Lake has a large parking lot. The lot is 1.4 acres of impervious surface that drains to one outlet location along the south edge of the parking lot. The volume and velocity of water runoff has caused erosion along a swale out to South Center Lake. No vegetation is able to withstand the energy of the water.

In November of 2014, two pretreatment chambers and rock rip rap was installed at the location where the runoff leaves the parking lot. The swale from the pretreatment chambers to the Ordinary High Water Level (OHWL) was lined with permanent turf reinforcement mat and planted. The swale was planted with native sedges that can handle the shady and wet conditions.
