# St. Croix River Escarpment Gully Inventory

## *2011 Inventory of Erosion Along the St. Croix River*

Prepared by the Chisago  
Soil & Water Conservation District

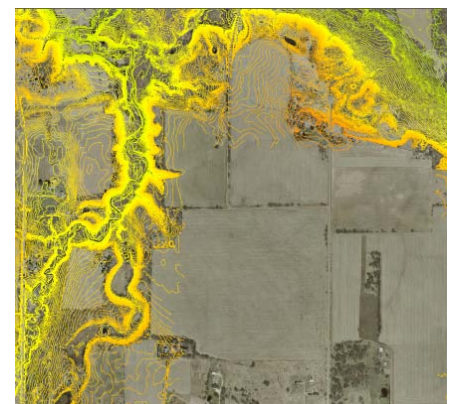
**Figure 1: Contours**

with 2007 LiDAR imaging as the primary aerial photography. Other layers that were imported and found to be helpful included: roads, parcels, township lines, section lines, contours (1-foot contours; See Figure 1), newer aerial photography (FSA or NAIP), rivers, and streams. To get an idea of the age of the gully, 1938 MN DNR aerial photographs were brought in and georeferenced. It was also helpful to have several different years of aerial photographs to compare as some photos seem to show different aspects better.

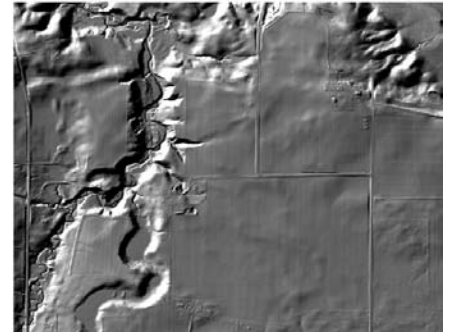
Figure 2: Hillshade

A helpful tool that wasn't used for this project, but in hindsight would be helpful, was the hillshade tool (See Figure 2). To use this tool, the DEM GRIDs for the area must be added to the project. It creates a nearly 3-dimensional view of the landscape that helps pick out areas that could be gullies. This could be especially helpful if a person is not experienced at reading contours.

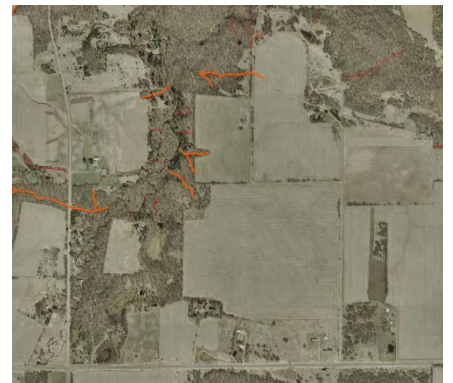
Figure 3: Identified Gullies

After all potential gullies were identified with a point file, the stems of the gullies were identified with a polyline file (See Figure 3). A polyline was drawn from the bottom point, following the main stem of the gully up to the head. For gullies with multiple heads, the initial line was drawn on what appeared to be the main or original stem of the gully. Secondary lines were then drawn off the main stem to connect to the points at the head of the potential gullies branching off the main stem. In cases where a gully went under a road via a culvert, the line continued over the roadway.

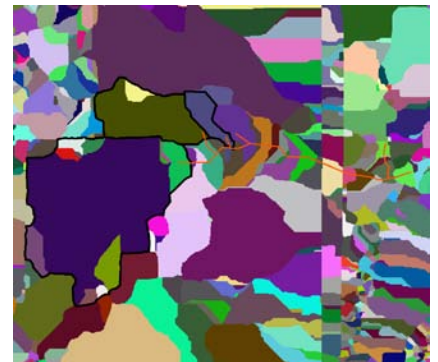
**Figure 4: Basins**

The tool that was used to create the watersheds was the Basin tool (See Figure 4), which required several steps before using. The DEM GRIDS for the areas including the gullies were added to the project and merged together. This process caused ArcGIS to become non-responsive several times. To avoid this, the project was broken into three separate project files, one for each of the three townships. This reduced the number of GRIDS needed for each project and allowed the merging to be conducted without problem. Once all of the GRIDS were merged into one file, the Filter tool was used. This smoothed out the data.

Next, the Flow Accumulation tool was run on the Filtered DEM. This tool highlights the areas of the highest flow accumulation. Then, the Basin tool was used to break the area into smaller basins. At this point, the basins were converted from a raster to a polygon shapefile.

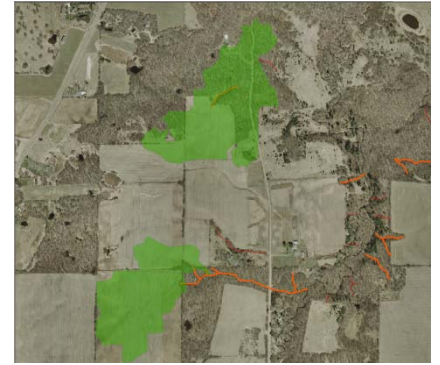
Figure 5: Watersheds

The next step in this process will focus on the shapefile that contains all of the gully watersheds. These watersheds will be ranked to highlight the watersheds that are of the highest priority and that funds should be directed to.

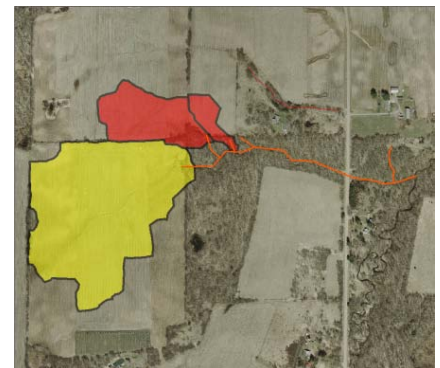
Figure 6: EBI Ranking

For this project, ranking criteria included the Environmental Benefit Index (EBI) and GAP Land cover Data. The EBI is a combination of three criteria and is ranked from high to low on a scale of 100. The three components of the EBI are:

erosion and 100 being the most likely land cover to contribute to erosion. A column was added to the attribute table and a ranking between 0 and 100 was assigned to each unique land cover class. The Level 3 Classification was used because it identified a difference between Cropland and Grassland, where Level 2 classified both these categories as Grassland. The GAP Land Cover data must be converted from a polygon to a raster after the ranking has been completed.

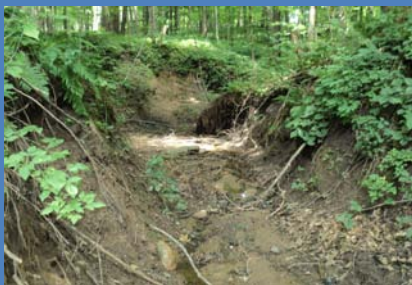
Figure 8: Gully Head

- Install a water and sediment control basin at the head of the gully with an underground pipe to a stable outlet.
- Install ditches along the road to capture and convey the water to a stable outlet.
- Implement agricultural best management practices that help reduce runoff from the farm field and stabilize the gully.

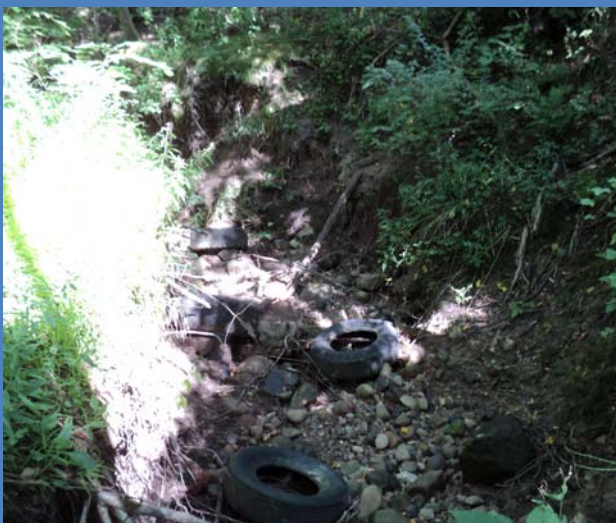
Gully 5 starts in an agricultural field that is row cropped. The gully actually starts about 50 feet from the wood line as a small channelized gully that appears to be farmed through every year. Once it gets into the woodland, the slope increases as does the size of the gully. The lower half of the drainage area consists of agricultural row cropland and the remainder is fallow with undisturbed grasses, scattered shrubs, and occasional trees. The gully flows through a dense hardwood forest. There were no invasive species observed. There is some trash and numerous tires that are in the bottom of the gully.

Figure 9. Upper Section of Gully

- Install a water and sediment control basin at the head of the gully with an underground pipe to a stable outlet.
- Implement agricultural best management practices that help reduce runoff from the farm field and stabilize the gully.
- Remove trash and debris from the channel.

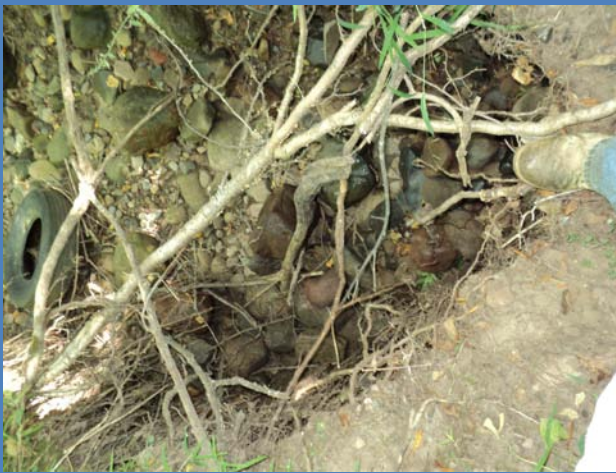
Figure 10. Erosion at Gully Head

- Install a water and sediment control basin at the head of the gully with an underground pipe to a stable outlet.
- Implement agricultural best management practices that help reduce runoff from the farm field and stabilize the gully.

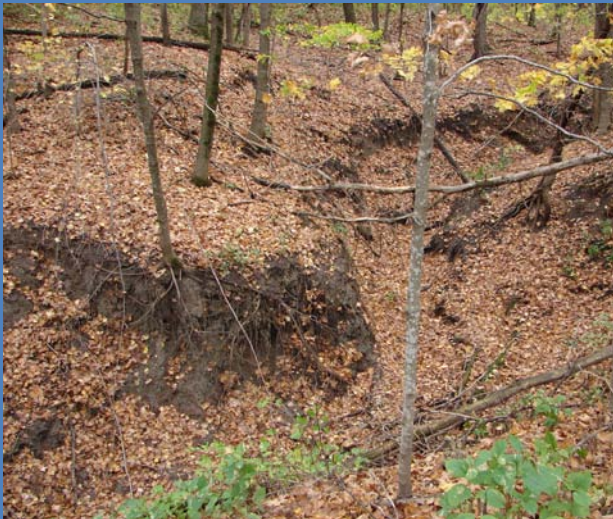
Gully 14 is eroding most severely at the top, with some side slope and bank sloughing located sporadically throughout the rest of gully. The gully runs through a mature hardwood forest in fair to good condition. There is at least 20% cover of Tartarian Honeysuckle in the shrub layer. European Buckthorn and Barberry (*Berberis sp.*) are present as well. The drainage area is fairly flat and approximately 90% of it is within an agricultural field that has a rotation of row crops on it. Once the gully begins, the slope increases dramatically.

Figure 11: Looking Up the Gully

- Install a water and sediment control basin at the head of the gully with an underground pipe to a stable outlet.
- Implement agricultural best management practices that help reduce runoff from the farm field and stabilize the gully.

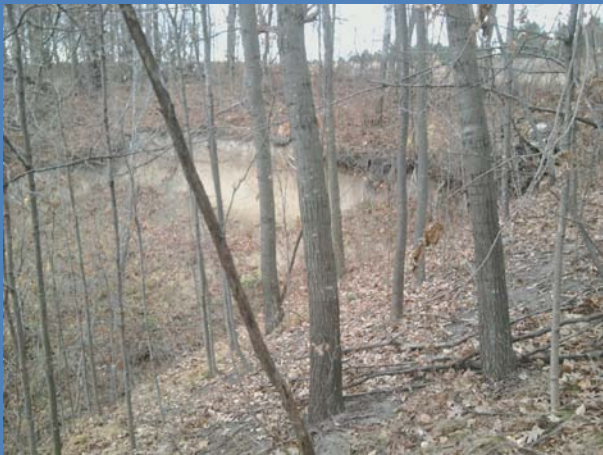
Figure 12: View of the Gully Head

- Install a water and sediment control basin at the head of the gully with an underground pipe to a stable outlet.

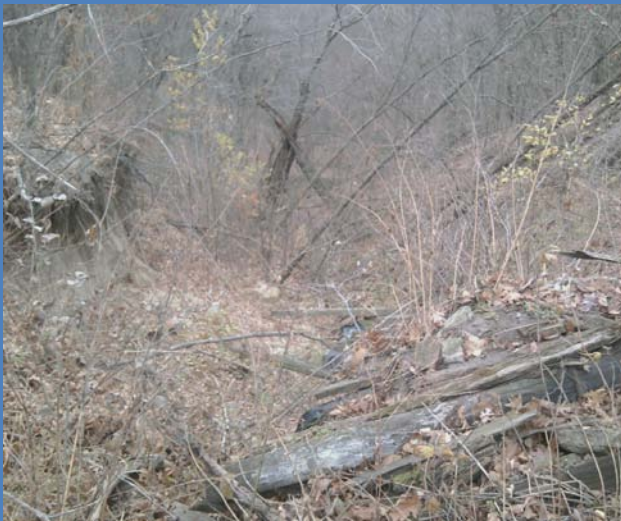
Figure 13: Looking Down at the Head of the Gully

- Install a water and sediment control basin at the head of the gully with an underground pipe to a stable outlet.
- Remove trash and debris from the channel.

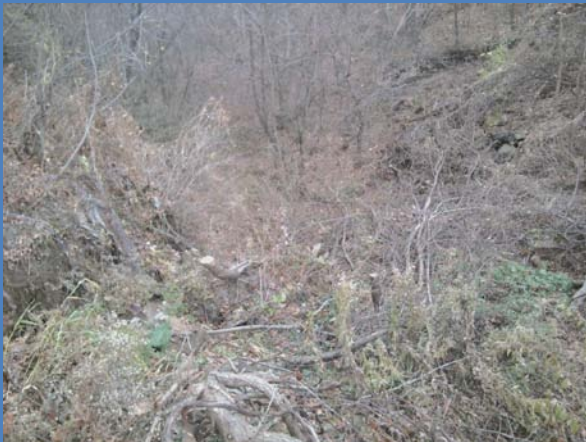
Figure 14: Looking Down at the Gully Head

- Install a water and sediment control basin at the head of the gully with an underground pipe to a stable outlet.
- Remove trash and debris from the channel.

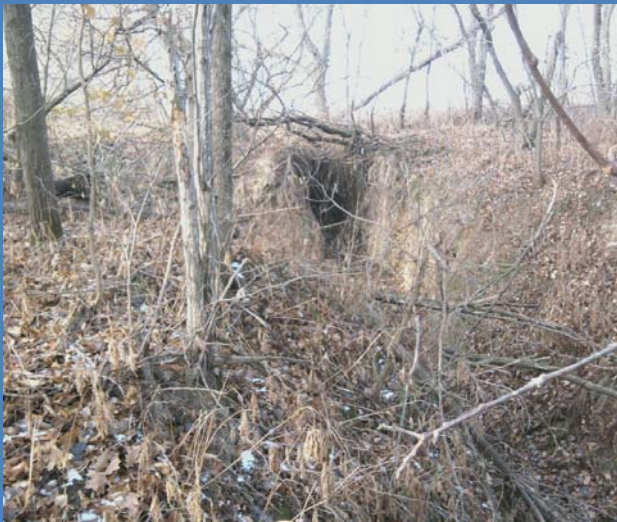
Figure 15: Looking Up at the Gully Head

- Install a water and sediment control basin at the head of the gully with an underground pipe to a stable outlet.
- Implement agricultural best management practices that help reduce runoff from the farm field and stabilize the gully.

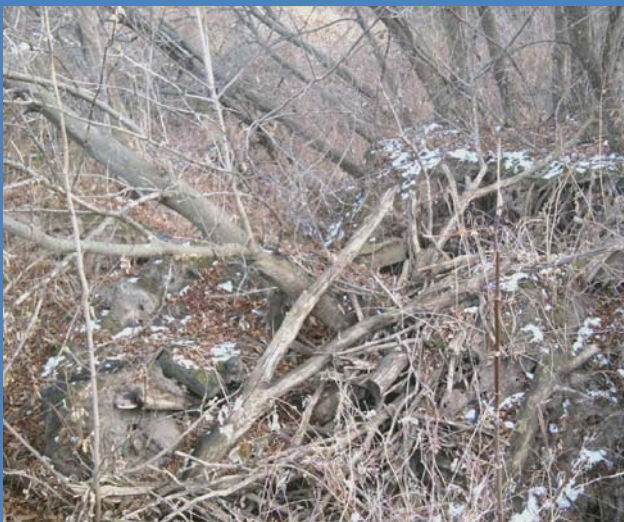
Figure 16: Looking Down at the Gully Head

- Install a water and sediment control basin at the head of the gully with an underground pipe to a stable outlet.
- Implement agricultural best management practices that help reduce runoff from the farm field and stabilize the gully.

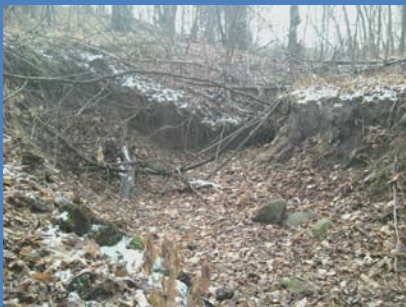
Figure 17: Lower Portion of Gully

- Install a water and sediment control basin at the head of the gully with an underground pipe to a stable outlet.
- Implement agricultural best management practices that help reduce runoff from the farm field and stabilize the gully.

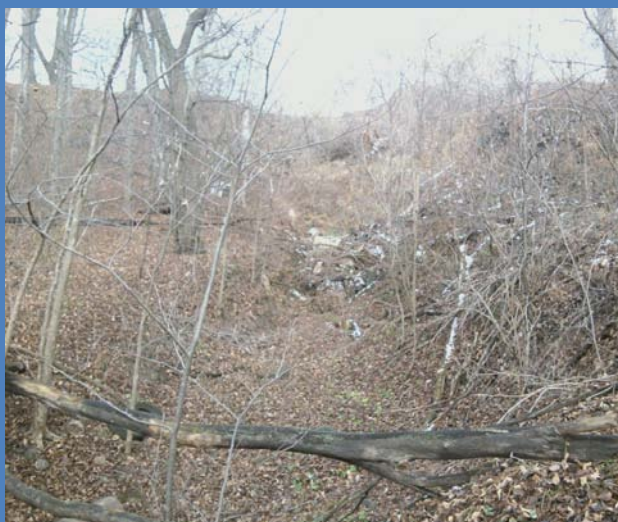
Figure 18: At the Bottom of the Gully Looking Up

- Install a water and sediment control basin at the head of the gully with an underground pipe to a stable outlet.
- Implement agricultural best management practices that help reduce runoff from the farm field and stabilize the gully.
- Remove trash and debris from the channel.

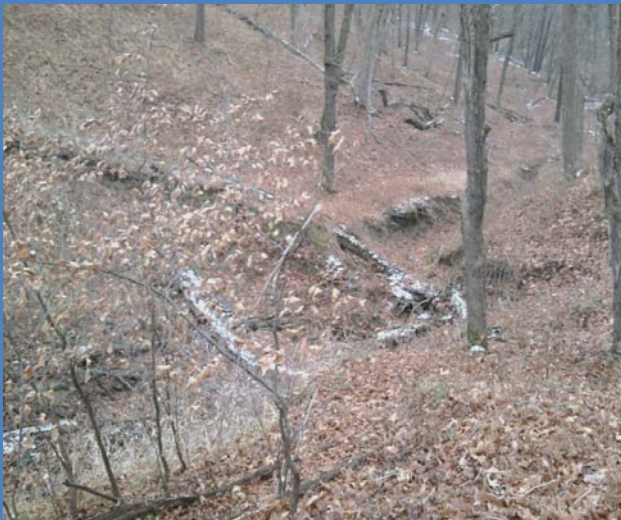
Gully 27 is the main stem with several other gullies connecting to it, including Gully 26. The erosion from this gully starts just before the intersection with Gully 26. The gully runs through a fairly dense mixed hardwood forest that is grazed. There were no invasive species observed in this area. The drainage area is small but steep. Most of it falls within a wooded pasture. Approximately 10-15% of the drainage area is in the agricultural field that is currently in hay.

Figure 19: Looking Down Slope

- Install a water and sediment control basin at the head of the gully with an underground pipe to a stable outlet.
- Implement agricultural best management practices that help reduce runoff from the farm field and stabilize the gully.

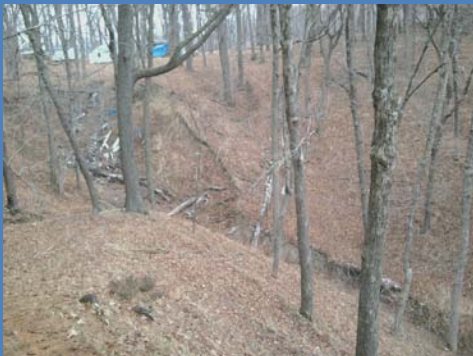
Figure 20: Middle Portion of Gully

- Restore the drained wetland by putting in a ditch plug.
- Install a water and sediment control basin at the head of the gully with an underground pipe to a stable outlet.
- Remove trash and debris from the channel.
- Install Best Management Practices such as rain gardens to capture and infiltrate water running off from impervious surfaces.

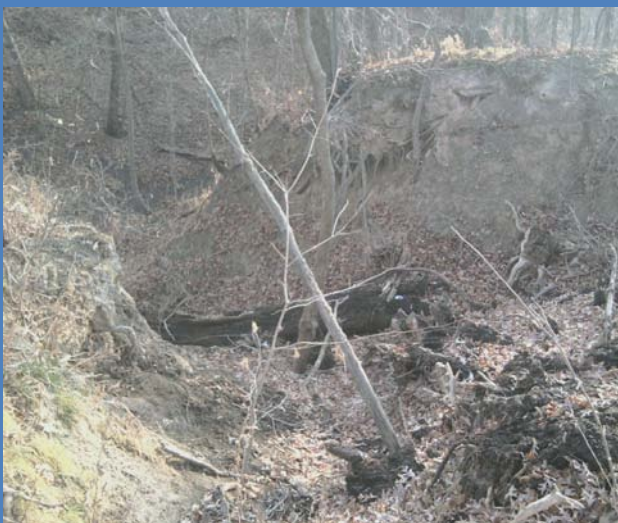
Gully 29 has an extreme amount of erosion starting at the top, but the length of the gully is fairly short. The head is wide and deeply cut. It is difficult to determine the actual depth because a lot of old hay and composted manure has been pushed into the gully. The gully runs through a mixed hardwood forest that is pastured occasionally. No invasive species were observed. The drainage area is almost completely in an agricultural field that is currently planted with hay. The remaining 5% of the watershed is within the tree line.

Figure 21: Gully Head; Note Old Hay and Composted Manure in Bottom Right of Photograph

- Install a water and sediment control basin at the head of the gully with an underground pipe to a stable outlet.
- Implement agricultural best management practices that help reduce runoff from the farm field and stabilize the gully.
