RURAL SUBWATERSHED ANALYSIS

RUSH LAKE WATERSHED

**PREPARED BY THE CHISAGO SOIL & WATER CONSERVATION DISTRICT IN
PARTNERSHIP WITH THE METRO CONSERVATION DISTRICTS**

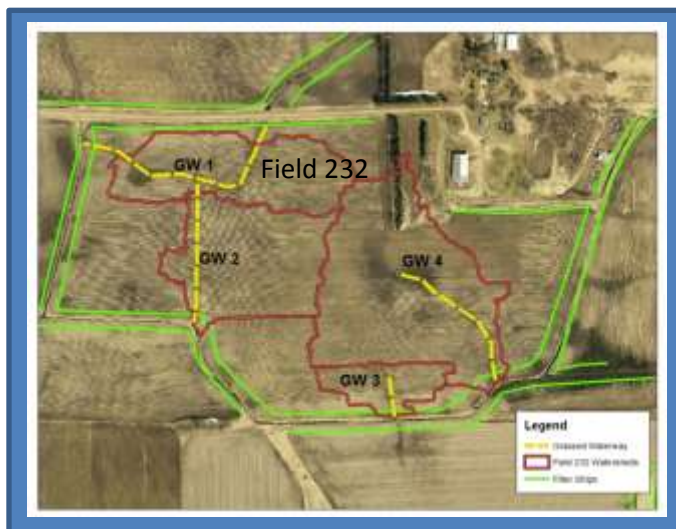
Catchment Summary	
Field Acres	47
Current Cover	Corn/Beans
# of Landowners	1
Removed TP (Lb/yr)	198
Removed TSS (Ton/yr)	185
Estimated Cost	\$21,979
Cost/Lb TP	\$111
Model Inputs	
Soil Type	346; 292
Slopes >6%	No

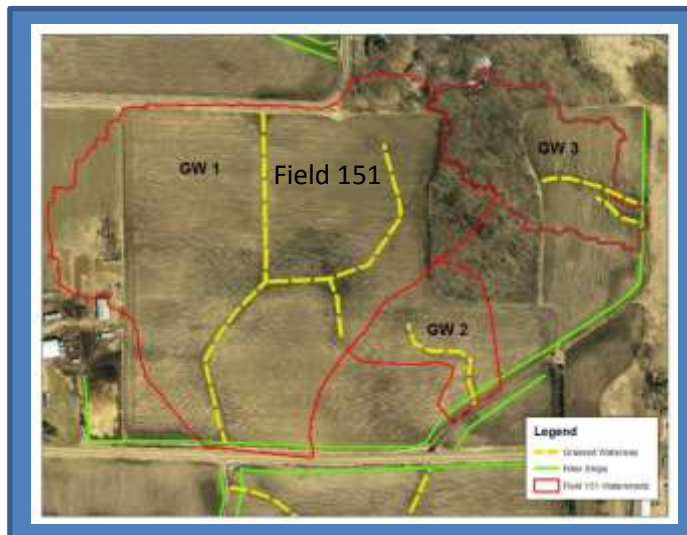
Catchment Summary	
Field Acres	45.6
Current Cover	Corn/Beans
# of Landowners	1
Removed TP (Lb/yr)	197
Removed TSS (Ton/yr)	182
Estimated Cost	\$23,911
Cost/Lb TP	\$121
Model Inputs	
Soil Type	346;292;75
Slopes >6%	No

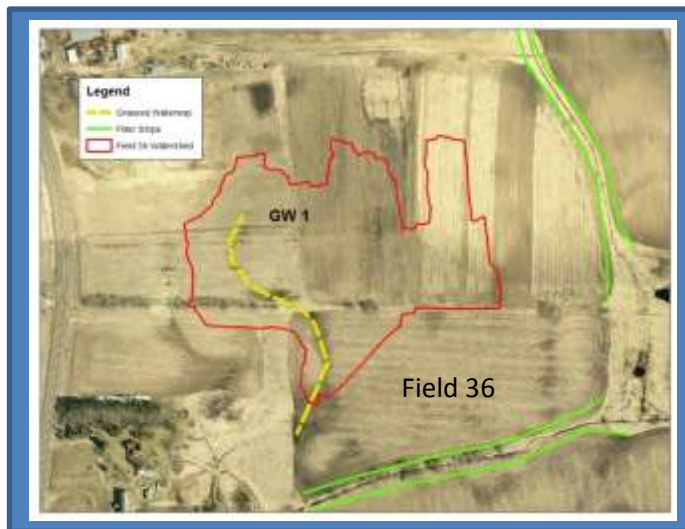
Catchment Summary	
Field Acres	11.6
Current Cover	Corn/Beans
# of Landowners	1
Removed TP (Lb/yr)	57
Removed TSS (Ton/yr)	56
Estimated Cost	\$7,733
Cost/Lb TP	\$136
Model Inputs	
Soil Type	346;292;75
Slopes >6%	No

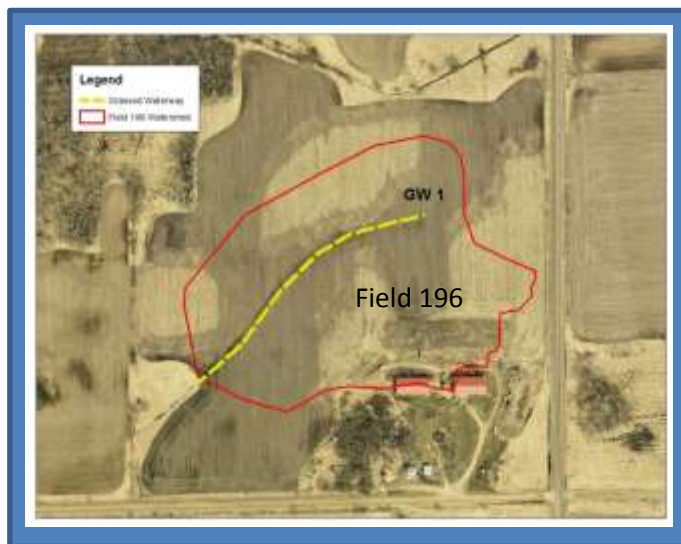
If the field is converted to an annual row crop, the concentrated flow path should remain a grassed waterway.

Catchment Summary	
Field Acres	27.3
Current Cover	Hay
# of Landowners	1
Removed TP (Lb/yr)	49
Removed TSS (Ton/yr)	49
Estimated Cost	\$5,518
Cost/Lb TP	\$113
Model Inputs	
Soil Type	346;292;75
Slopes >6%	No

Practice	Removed TP (Lb/yr)	Removed TSS (Ton/yr)	Watershed Size (Acres)	Average Watershed Slope	Distance to Surface Water (Feet)	Length (Feet)	Estimated Cost	Cost/Lb TP
GW 1	49	49	14	1.2	0'	903'	\$5,518	\$113

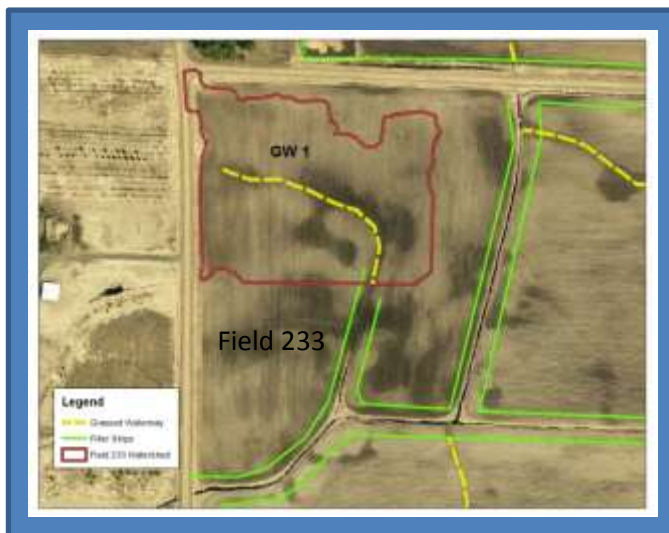
A grassed waterway should be installed to correct the erosion within the concentrated flow path. There should be a 50-foot filter strip between the edge of the field and the ditches.

Catchment Summary	
Field Acres	15.6
Current Cover	Corn/Beans
# of Landowners	1
Removed TP (Lb/yr)	45
Removed TSS (Ton/yr)	42
Estimated Cost	\$6,922
Cost/Lb TP	\$154
Model Inputs	
Soil Type	346;75
Slopes >6%	No

Practice	Removed TP (Lb/yr)	Removed TSS (Ton/yr)	Watershed Size (Acres)	Average Watershed Slope	Distance to Surface Water (Feet)	Length (Feet)	Estimated Cost	Cost/Lb TP
GW 1	33	33	5.8	1.8	0'	562'	\$4,069	\$123
Practice	Removed TP (Lb/yr)	Removed TSS (Ton/yr)	Existing Filter Strip (Feet)			Area (Acres)	Estimated Cost	Cost/Lb TP
Filter Strip	12	9	<5'			2.3	\$2,853	\$238

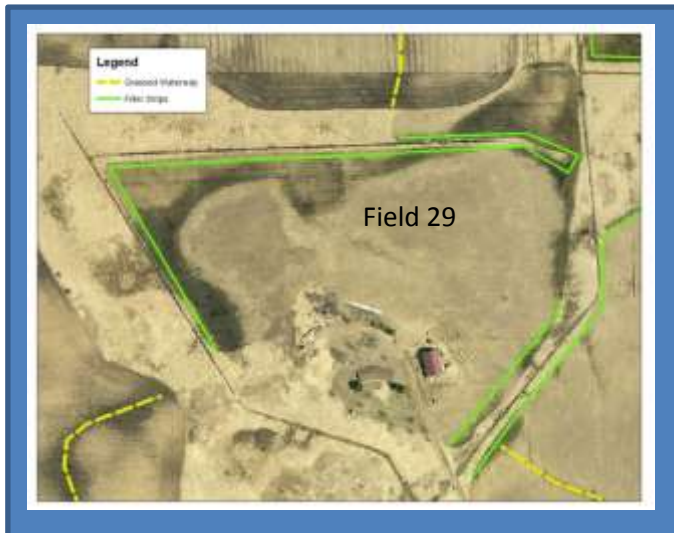
If this field is converted to an annual row crop, a 50-foot filter strip should remain between the field edge and all ditches.

Catchment Summary	
Field Acres	13.6
Current Cover	Hay
# of Landowners	1
Removed TP (Lb/yr)	26
Removed TSS (Ton/yr)	22
Estimated Cost	\$3,312
Cost/Lb TP	\$127
Model Inputs	
Soil Type	346;75;544
Slopes >6%	Partially

Practice	Removed TP (Lb/yr)	Removed TSS (Ton/yr)	Existing Filter Strip (Feet)	Area (Acres)	Estimated Cost	Cost/Lb TP
Filter Strip	26	22	50'	3.2	\$3,312	\$127

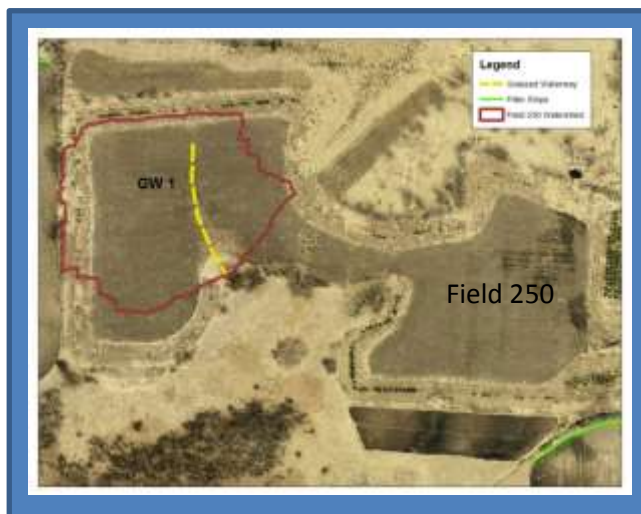
A grassed waterway should be installed to stabilize erosion within the concentrated flow path.

Catchment Summary	
Field Acres	16.6
Current Cover	Corn/Beans
# of Landowners	1
Removed TP (Lb/yr)	22
Removed TSS (Ton/yr)	22
Estimated Cost	\$3,635
Cost/Lb TP	\$165
Model Inputs	
Soil Type	292;346;75
Slopes >6%	No

Practice	Removed TP (Lb/yr)	Removed TSS (Ton/yr)	Watershed Size (Acres)	Average Watershed Slope	Distance to Surface Water (Feet)	Length (Feet)	Estimated Cost	Cost/Lb TP
GW 1	22	22	8.3	2.2	145'	460'	\$3,635	\$165

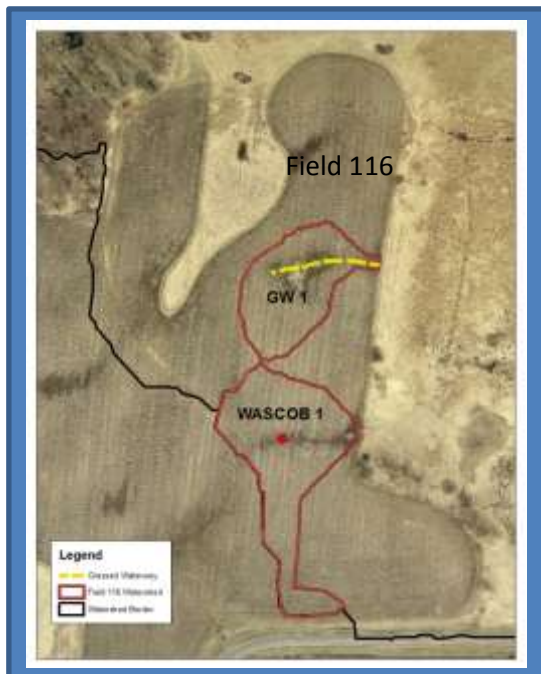
A grassed waterway and a water and sediment control basin should be installed to correct the erosion within the concentrated flow areas.

Catchment Summary	
Field Acres	10.6
Current Cover	Corn/Beans
# of Landowners	1
Removed TP (Lb/yr)	17
Removed TSS (Ton/yr)	17
Estimated Cost	\$12,445
Cost/Lb TP	\$732
Model Inputs	
Soil Type	292;204C;75
Slopes >6%	Partially

Practice	Removed TP (Lb/yr)	Removed TSS (Ton/yr)	Watershed Size (Acres)	Average Watershed Slope	Distance to Surface Water (Feet)	Length (Feet)	Estimated Cost	Cost/Lb TP
GW 1	12	12	1.0	1.7	0'	226'	\$2,641	\$132
Practice	Removed TP (Lb/yr)	Removed TSS (Ton/yr)	Watershed Size (Acres)	Average Watershed Slope	Distance to Surface Water (Feet)		Estimated Cost	Cost/Lb TP
WASCOB 1	5	5	1.5	2.9	0'		\$9,804	\$1,960

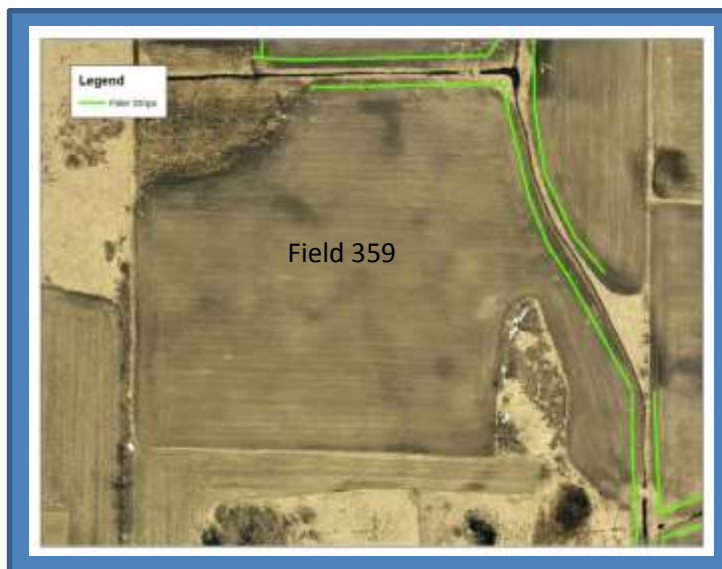
A 50-foot filter strip should be installed between the drainage ditch and the edge of the field.

Catchment Summary	
Field Acres	18.9
Current Cover	Corn/Beans
# of Landowners	1
Removed TP (Lb/yr)	17
Removed TSS (Ton/yr)	11
Estimated Cost	\$2,598
Cost/Lb TP	\$153
Model Inputs	
Soil Type	292;346;75
Slopes >6%	No

Practice	Removed TP (Lb/yr)	Removed TSS (Ton/yr)	Existing Filter Strip (Feet)	Area (Acres)	Estimated Cost	Cost/Lb TP
Filter Strip	17	11	<5'	1.8	\$2,598	\$153

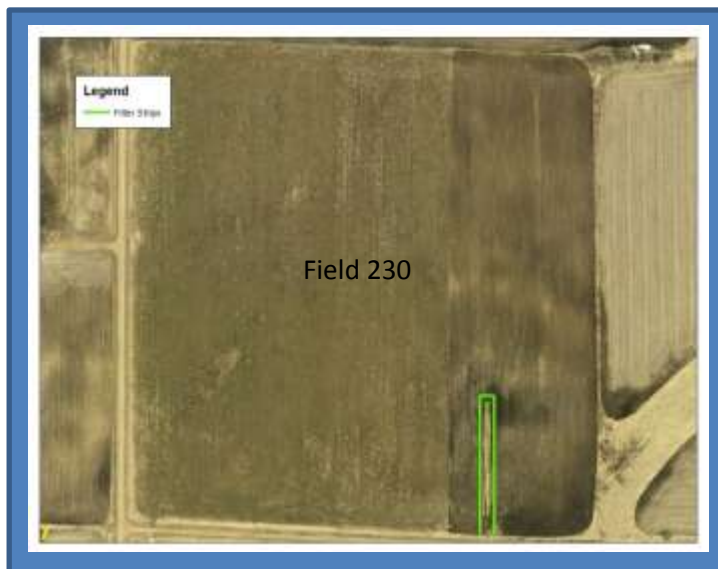
If the field is converted to an annual row crop, a 50-foot filter strip should be left around the drainage ditch.

Catchment Summary	
Field Acres	37.0
Current Cover	Hay
# of Landowners	1
Removed TP (Lb/yr)	15
Removed TSS (Ton/yr)	10
Estimated Cost	\$2,139
Cost/Lb TP	\$143
Model Inputs	
Soil Type	292;346;204B
Slopes >6%	No

Practice	Removed TP (Lb/yr)	Removed TSS (Ton/yr)	Existing Filter Strip (Feet)	Area (Acres)	Estimated Cost	Cost/Lb TP
Filter Strip	15	10	<5'	0.9	\$2,139	\$143

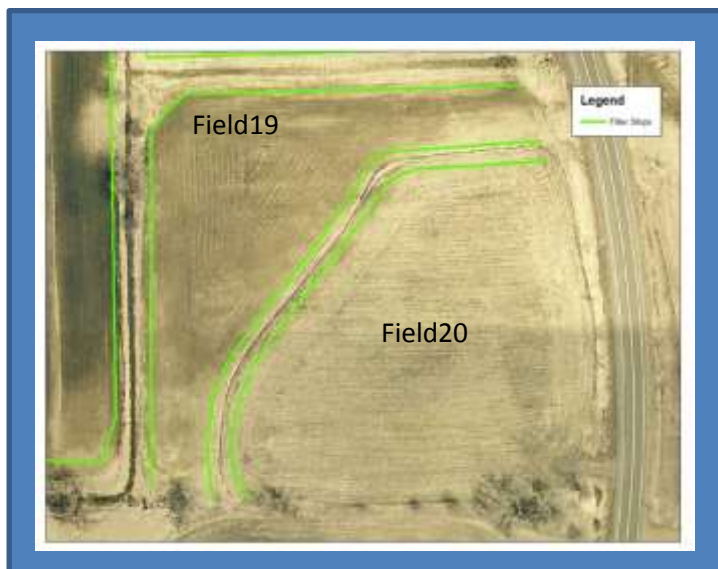
If the field is converted to an annual row crop, a 50-foot filter strip should be left around the drainage ditches.

Catchment Summary	
Field Acres	4.8
Current Cover	Hay
# of Landowners	1
Removed TP (Lb/yr)	14
Removed TSS (Ton/yr)	12
Estimated Cost	\$2,853
Cost/Lb TP	\$204
Model Inputs	
Soil Type	292;346;204C
Slopes >6%	Yes

Practice	Removed TP (Lb/yr)	Removed TSS (Ton/yr)	Existing Filter Strip (Feet)	Area (Acres)	Estimated Cost	Cost/Lb TP
Filter Strip	14	12	50'	2.3	\$2,853	\$204

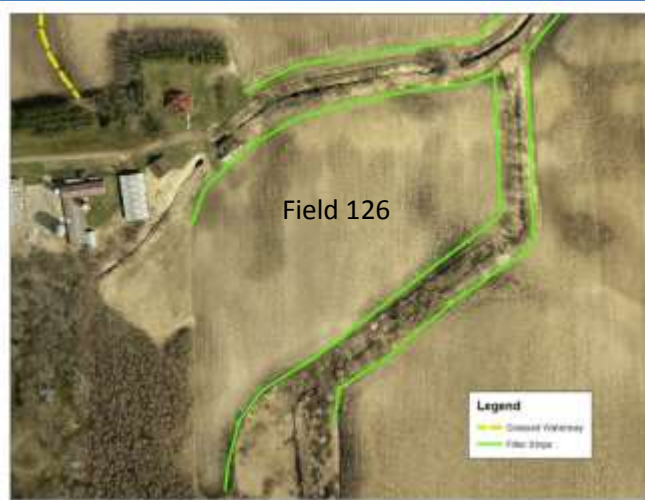
A 50-foot filter strip should be installed between the drainage ditches and the edge of the field.

Field Acres	8.1
Current Cover	Corn/Beans
# of Landowners	1
Removed TP (Lb/yr)	14
Removed TSS (Ton/yr)	10
Estimated Cost	\$2,904
Cost/Lb TP	\$207
Model Inputs	
Soil Type	292;346;75;204B
Slopes >6%	No

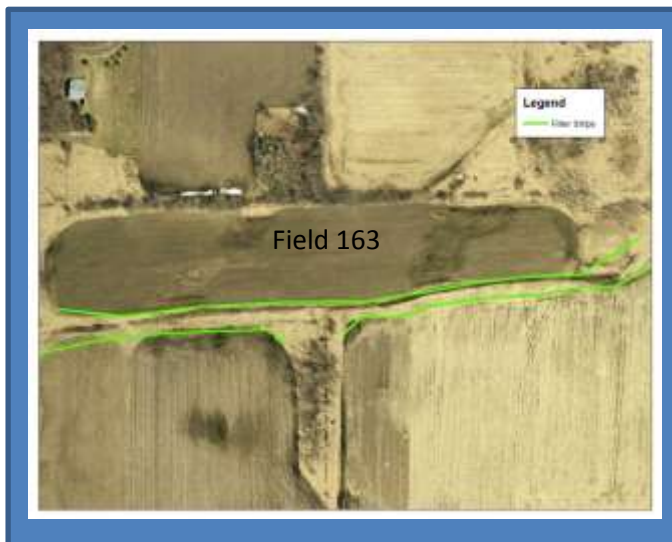
A 50-foot filter strip should be installed between the ditch and the edge of the field.

Catchment Summary	
Field Acres	6.2
Current Cover	Corn/Beans
# of Landowners	1
Removed TP (Lb/yr)	11
Removed TSS (Ton/yr)	7
Estimated Cost	\$2,496
Cost/Lb TP	\$227
Model Inputs	
Soil Type	75
Slopes >6%	No

Practice	Removed TP (Lb/yr)	Removed TSS (Ton/yr)	Existing Filter Strip (Feet)	Area (Acres)	Estimated Cost	Cost/Lb TP
Filter Strip	11	7	<5'	1.6	\$2,496	\$227

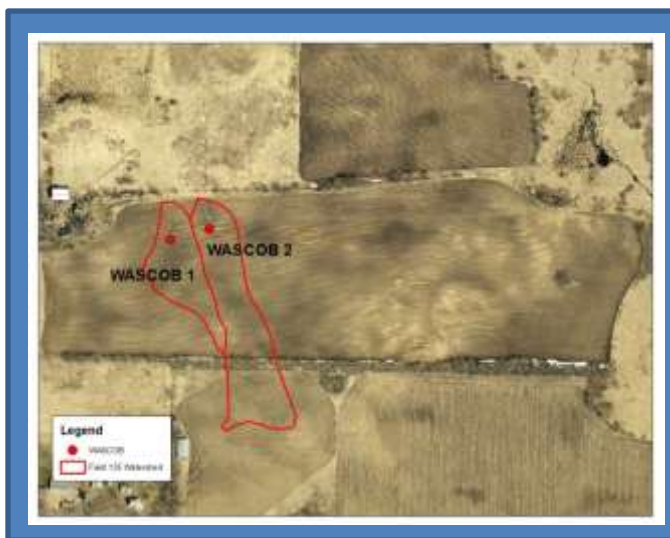
A water and sediment control basin should be installed to stabilize erosion occurring within the concentrated flow paths.

Catchment Summary	
Field Acres	31.6
Current Cover	Corn/Beans
# of Landowners	1
Removed TP (Lb/yr)	8
Removed TSS (Ton/yr)	8
Estimated Cost	\$19,608
Cost/Lb TP	\$2,451
Model Inputs	
Soil Type	292;346;928C
Slopes >6%	Partially

Practice	Removed TP (Lb/yr)	Removed TSS (Ton/yr)	Watershed Size (Acres)	Average Watershed Slope	Distance to Surface Water (Feet)	Estimated Cost	Cost/Lb TP
WASC OB 1	3	3	1.8	4.1	304'	\$9,804	\$3,268
WASC OB 2	5	5	3.6	4.0	307'	\$9,804	\$1,961

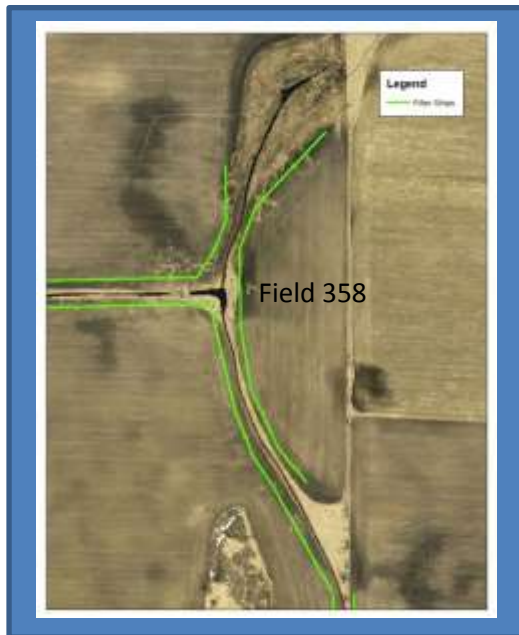
A 50-foot filter strip should be installed between the drainage ditch and the edge of the field.

Catchment Summary	
Field Acres	5.1
Current Cover	Corn/Beans
# of Landowners	1
Removed TP (Lb/yr)	7
Removed TSS (Ton/yr)	4
Estimated Cost	\$2,292
Cost/Lb TP	\$327
Model Inputs	
Soil Type	75;346
Slopes >6%	No

Practice	Removed TP (Lb/yr)	Removed TSS (Ton/yr)	Existing Filter Strip (Feet)	Area (Acres)	Estimated Cost	Cost/Lb TP
Filter Strip	7	4	10-15'	1.2	\$2,292	\$327

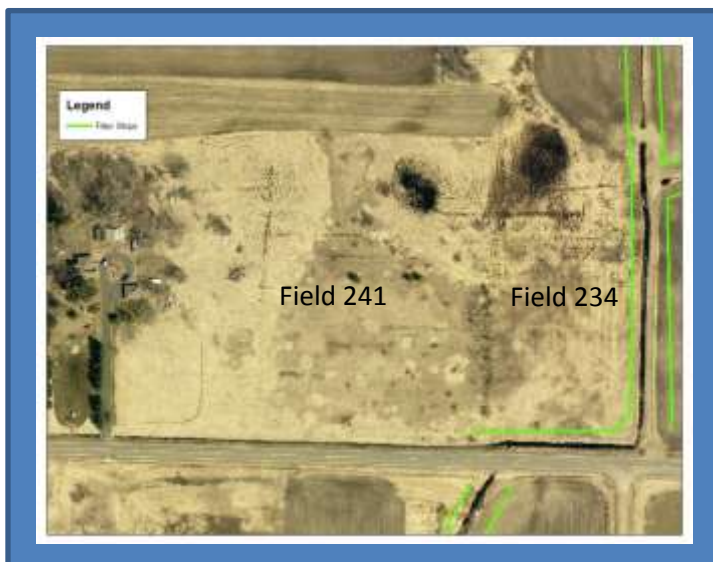
If this field is converted to annual row crops, a 50-foot buffer should remain between the edge of the field and the drainage ditch.

Catchment Summary	
Field Acres	10.6
Current Cover	Scrub Shrub
# of Landowners	1
Removed TP (Lb/yr)	7
Removed TSS (Ton/yr)	4
Estimated Cost	\$2,088
Cost/Lb TP	\$298
Model Inputs	
Soil Type	75;346;292
Slopes >6%	No

Practice	Removed TP (Lb/yr)	Removed TSS (Ton/yr)	Existing Filter Strip (Feet)	Area (Acres)	Estimated Cost	Cost/Lb TP
Filter Strip	7	4	50'	0.8	\$2,088	\$298

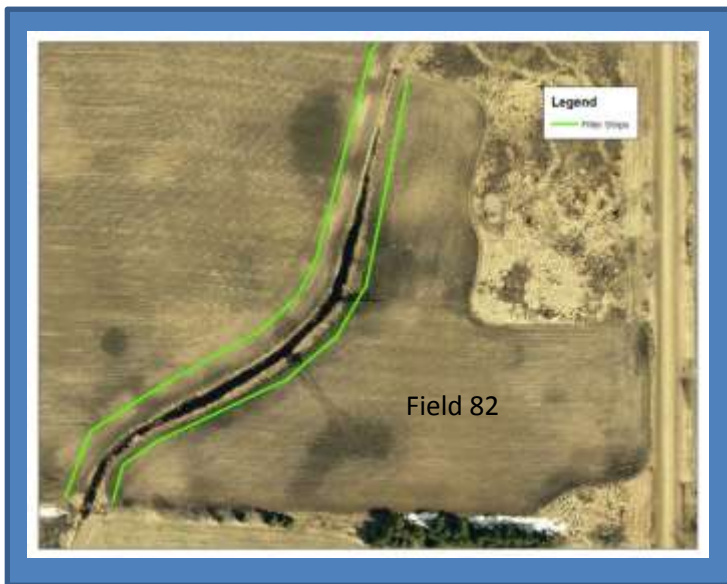
A 50-foot filter strip should be installed between the drainage ditch and the edge of the field.

Catchment Summary	
Field Acres	7.3
Current Cover	Corn/Beans
# of Landowners	1
Removed TP (Lb/yr)	6
Removed TSS (Ton/yr)	4
Estimated Cost	\$2,241
Cost/Lb TP	\$374
Model Inputs	
Soil Type	75;346
Slopes >6%	No

Practice	Removed TP (Lb/yr)	Removed TSS (Ton/yr)	Existing Filter Strip (Feet)	Area (Acres)	Estimated Cost	Cost/Lb TP
Filter Strip	6	4	5-15'	1.1	\$2,241	\$374

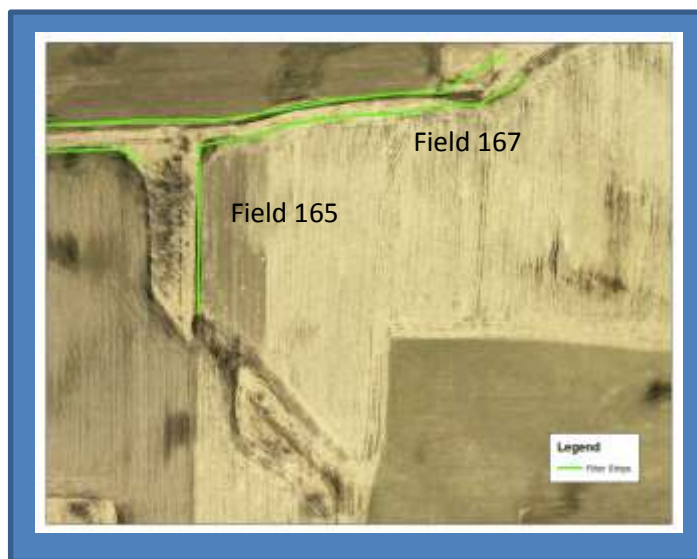
A 50-foot filter strip should be installed between the drainage ditch and the edge of the field.

Catchment Summary	
Field Acres	9.8
Current Cover	Corn/Beans
# of Landowners	1
Removed TP (Lb/yr)	5
Removed TSS (Ton/yr)	3
Estimated Cost	\$2,343
Cost/Lb TP	\$469
Model Inputs	
Soil Type	75;292;346
Slopes >6%	No

Practice	Removed TP (Lb/yr)	Removed TSS (Ton/yr)	Existing Filter Strip (Feet)	Area (Acres)	Estimated Cost	Cost/Lb TP
Filter Strip	5	3	5-30'	1.3	\$2,343	\$469

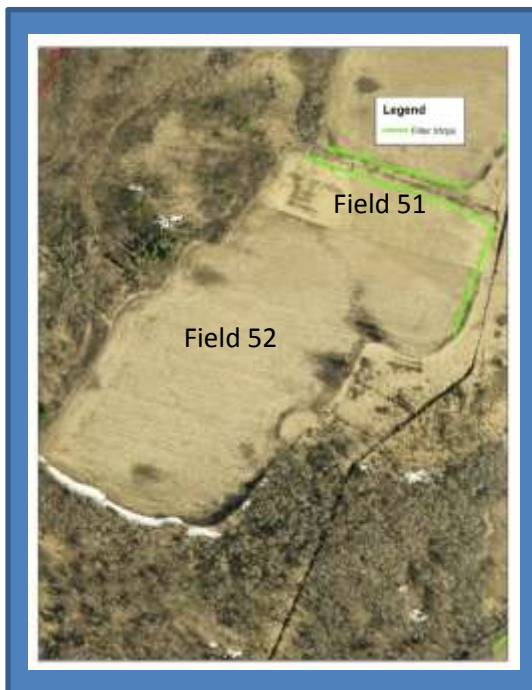
If the hay field is converted to an annual row crop, a 50-foot filter strip should remain between the ditches and edge of the field. On the corn-soybean field, a 50-foot filter strip should be installed between the ditch and the edge of the field.

Catchment Summary	
Field Acres	19.8
Current Cover	Hay/Corn/Beans
# of Landowners	1
Removed TP (Lb/yr)	3
Removed TSS (Ton/yr)	2
Estimated Cost	\$2,598
Cost/Lb TP	\$866
Model Inputs	
Soil Type	346;544;75
Slopes >6%	No

Practice	Removed TP (Lb/yr)	Removed TSS (Ton/yr)	Existing Filter Strip (Feet)	Area (Acres)	Estimated Cost	Cost/Lb TP
Filter Strip	3	2	50'	1.8	\$2,598	\$866

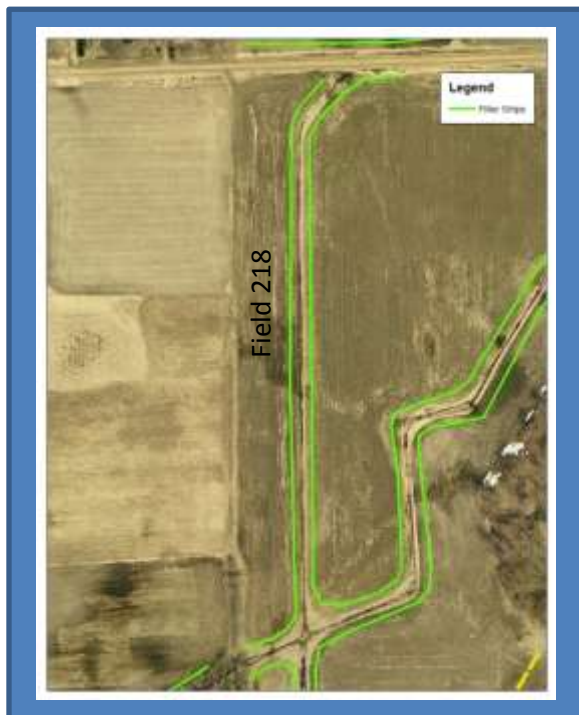
A 50-foot filter strip should be installed between the ditch and edge of the field.

Catchment Summary	
Field Acres	5.2
Current Cover	Corn/Beans
# of Landowners	1
Removed TP (Lb/yr)	3
Removed TSS (Ton/yr)	2
Estimated Cost	\$2,598
Cost/Lb TP	\$866
Model Inputs	
Soil Type	346
Slopes >6%	No

Practice	Removed TP (Lb/yr)	Removed TSS (Ton/yr)	Existing Filter Strip (Feet)	Area (Acres)	Estimated Cost	Cost/Lb TP
Filter Strip	3	2	<5'	1.8	\$2,598	\$866

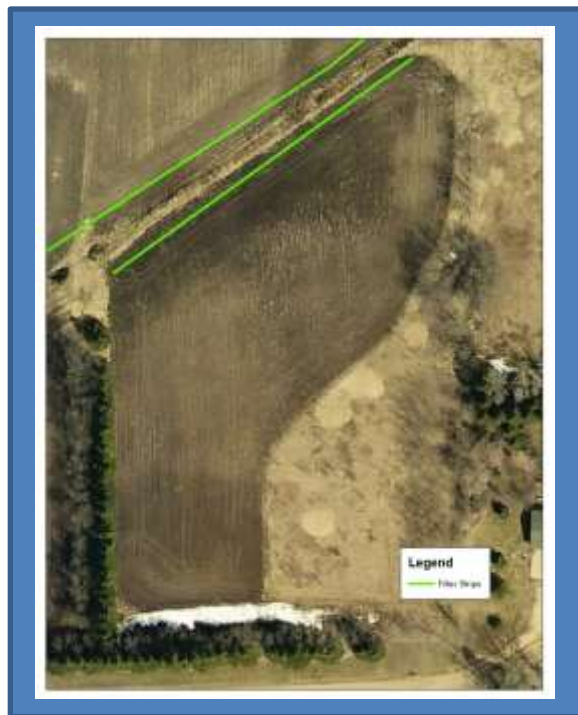
A 50-foot filter strip should be installed between the ditch and edge of the field.

Catchment Summary	
Field Acres	2.0
Current Cover	Corn/Beans
# of Landowners	1
Removed TP (Lb/yr)	2
Removed TSS (Ton/yr)	1
Estimated Cost	\$1,884
Cost/Lb TP	\$942
Model Inputs	
Soil Type	292;75
Slopes >6%	No

Practice	Removed TP (Lb/yr)	Removed TSS (Ton/yr)	Existing Filter Strip (Feet)	Area (Acres)	Estimated Cost	Cost/Lb TP
Filter Strip	2	1	<5'	0.4	\$1,884	\$942

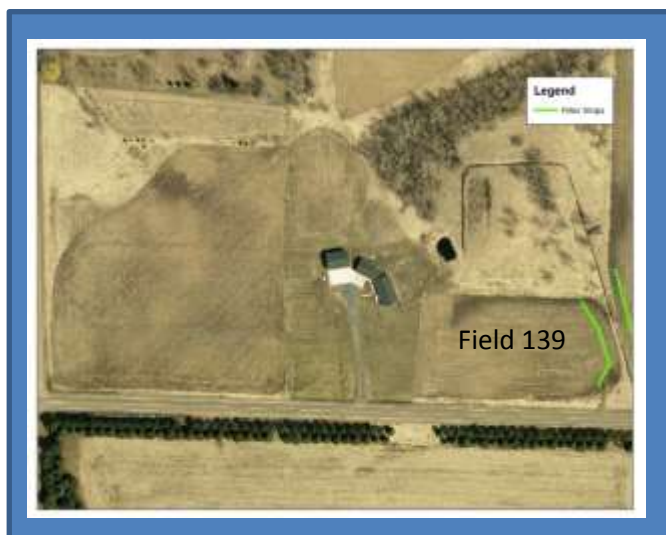
If this field is converted to an annual row crop, a 50-foot filter strip should remain between the ditch and edge of the field.

Catchment Summary	
Field Acres	7.9
Current Cover	Hay
# of Landowners	1
Removed TP (Lb/yr)	2
Removed TSS (Ton/yr)	1
Estimated Cost	\$1,782
Cost/Lb TP	\$891
Model Inputs	
Soil Type	346;292
Slopes >6%	No

Practice	Removed TP (Lb/yr)	Removed TSS (Ton/yr)	Existing Filter Strip (Feet)	Area (Acres)	Estimated Cost	Cost/Lb TP
Filter Strip	2	1	<5'	0.2	\$1,782	\$891

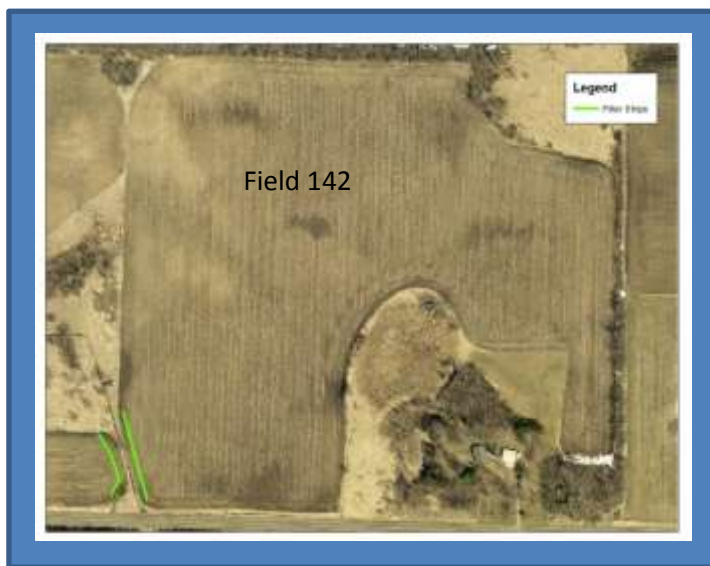
A 50-foot filter strip should be installed between the ditch and edge of the field.

Catchment Summary	
Field Acres	29.9
Current Cover	Corn/Beans
# of Landowners	1
Removed TP (Lb/yr)	2
Removed TSS (Ton/yr)	1
Estimated Cost	\$1,833
Cost/Lb TP	\$942
Model Inputs	
Soil Type	346;292
Slopes >6%	No

Practice	Removed TP (Lb/yr)	Removed TSS (Ton/yr)	Existing Filter Strip (Feet)	Area (Acres)	Estimated Cost	Cost/Lb TP
Filter Strip	2	1	<5'	0.3	\$1,833	\$942

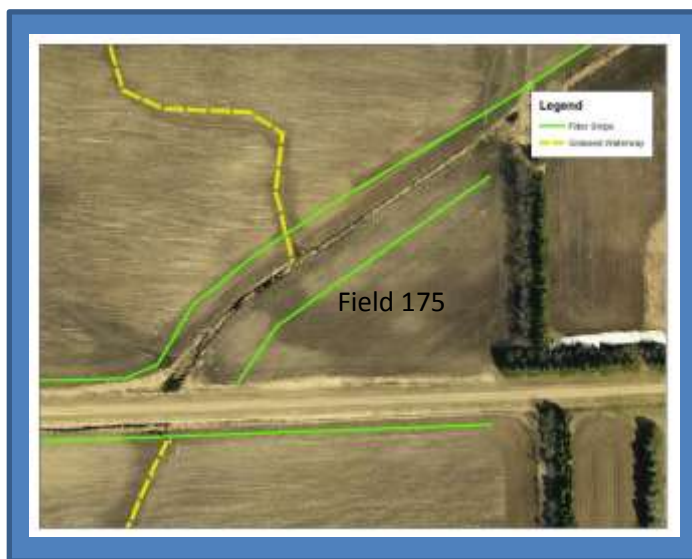
A 50-foot filter strip should be installed between the ditch and edge of the field.

Catchment Summary	
Field Acres	2.1
Current Cover	Corn/Beans
# of Landowners	1
Removed TP (Lb/yr)	2
Removed TSS (Ton/yr)	1
Estimated Cost	\$1,935
Cost/Lb TP	\$968
Model Inputs	
Soil Type	346;75
Slopes >6%	No

Practice	Removed TP (Lb/yr)	Removed TSS (Ton/yr)	Existing Filter Strip (Feet)	Area (Acres)	Estimated Cost	Cost/Lb TP
Filter Strip	2	1	<5'	0.5	\$1,935	\$968

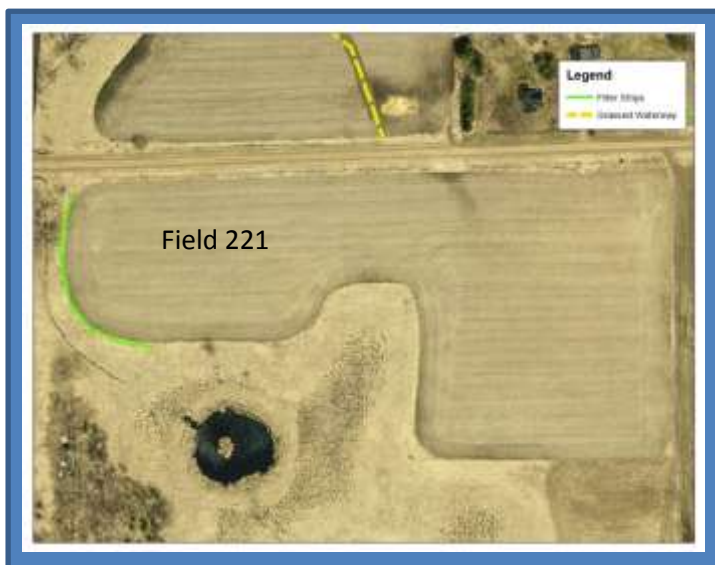
A 50-foot filter strip should be installed between the ditch and the edge of the field.

Catchment Summary	
Field Acres	10.0
Current Cover	Corn/Bean
# of Landowners	1
Removed TP (Lb/yr)	2
Removed TSS (Ton/yr)	0
Estimated Cost	\$1,884
Cost/Lb TP	\$942
Model Inputs	
Soil Type	292;204B;346
Slopes >6%	No

Practice	Removed TP (Lb/yr)	Removed TSS (Ton/yr)	Existing Filter Strip (Feet)	Area (Acres)	Estimated Cost	Cost/Lb TP
Filter Strip	2	0	25-45'	0.4	\$1,884	\$942

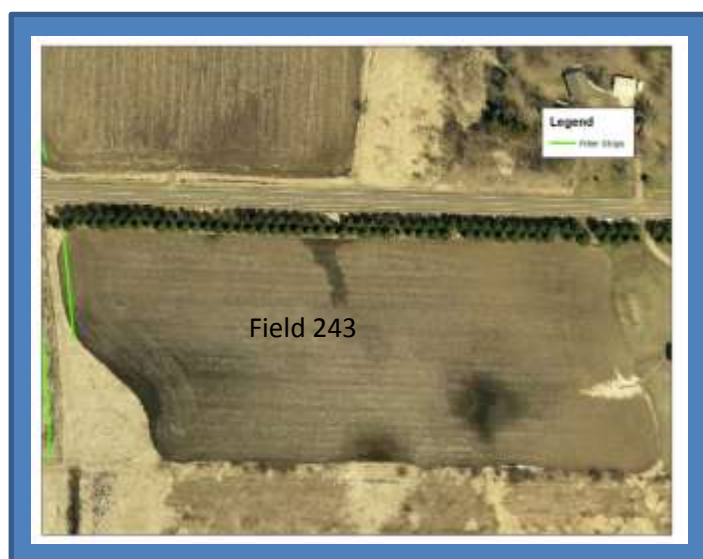
A 50-foot filter strip should be installed between the ditch and the edge of the field.

Catchment Summary	
Field Acres	8.5
Current Cover	Corn/Beans
# of Landowners	1
Removed TP (Lb/yr)	1
Removed TSS (Ton/yr)	0
Estimated Cost	\$1,782
Cost/Lb TP	\$1,782
Model Inputs	
Soil Type	346;292
Slopes >6%	No

Practice	Removed TP (Lb/yr)	Removed TSS (Ton/yr)	Existing Filter Strip (Feet)	Area (Acres)	Estimated Cost	Cost/Lb TP
Filter Strip	1	0	20'	0.2	\$1,782	\$1,782

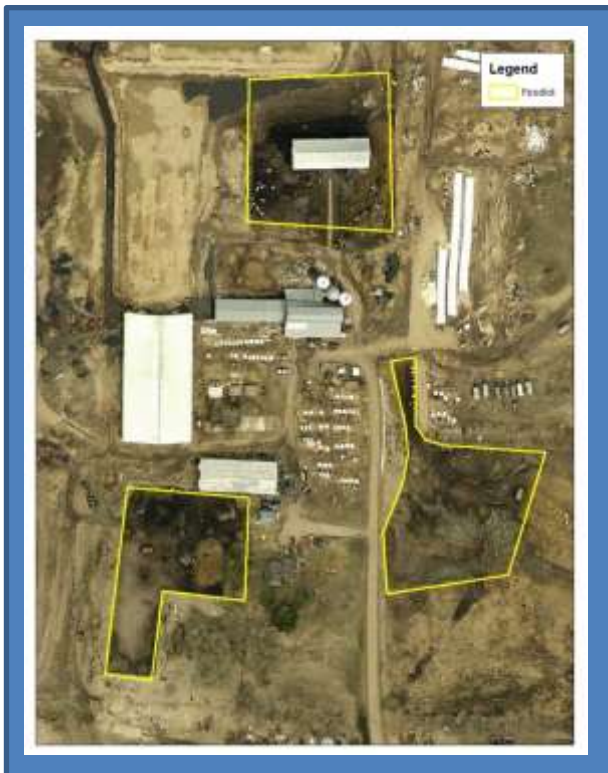
This is a farm with multiple animal operation locations with over 700 animals. The closest animal operation is less than 500 feet from a stream that drains to Rush Lake. The two southern animal operations are in a neighboring watershed.

Catchment Summary	
Animal operation Acres	3.4
#/Type Animal	250+ Bovine
# of Landowners	1
Soil Type	292;204B
Wetlands Present	No
Streams Present	No
Ditching Present	No
Distance to Surface Water	485'

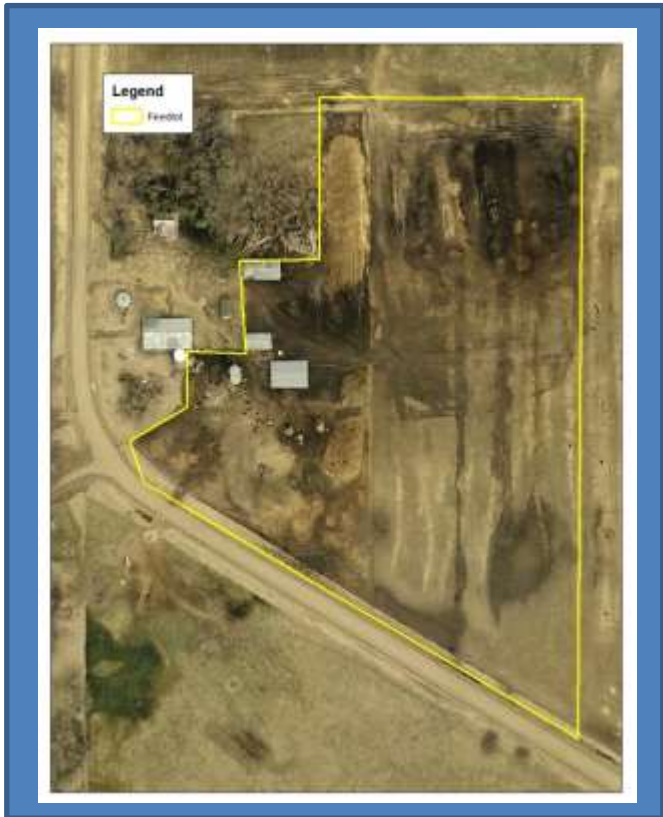
This is an animal operation of about 7 acres used for approximately 300 replacement animals. The animal operation drains to the road ditch on the south side, which empties into a stream less than 750 feet away.

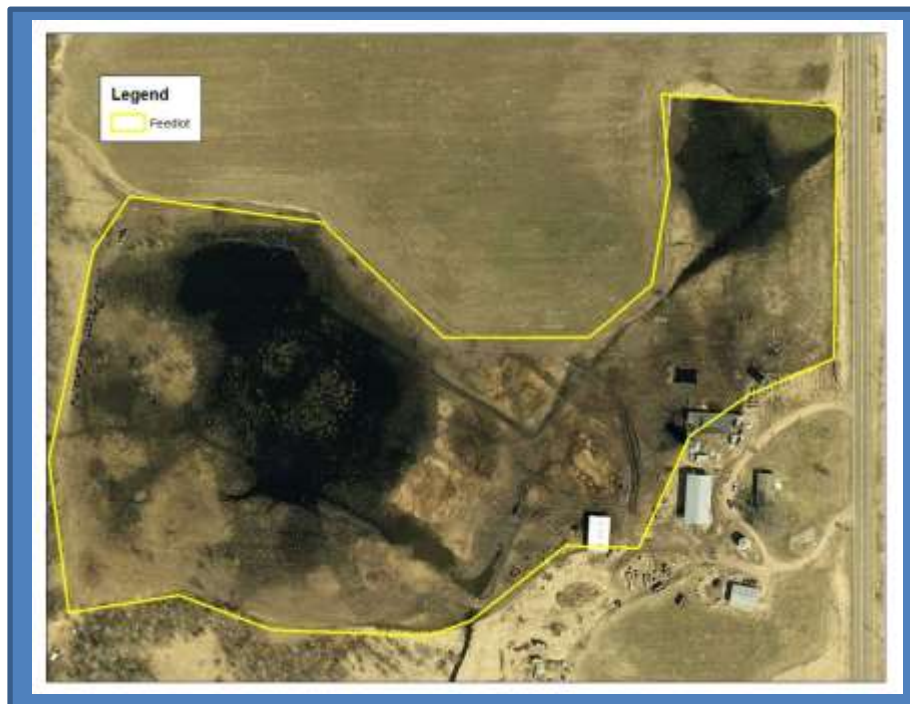
Rush Lake Watershed-Animal operation 277

This is an animal operation of about 15 acres. A ditch runs from across the road through a culvert through the middle of the animal operation. A portion of the animal operation is also classified as a wetland.

Catchment Summary	
Animal operation Acres	15.2
#/Type Animal	11-100 Bovine
# of Landowners	1
Soil Type	346;75
Wetlands Present	Yes
Streams Present	No
Ditching Present	Yes
Distance to Surface Water	0'

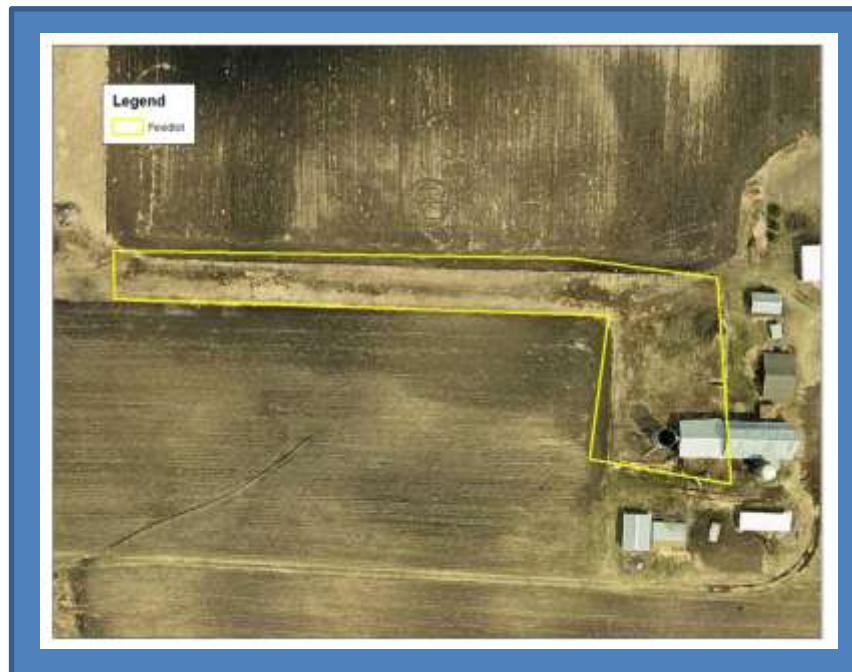
This is an animal operation of about 1 acre. Most of the animal operation drains through the adjacent agricultural field, through a gully, and into a wetland. It appears that this site has recently been taken out of operation.

Catchment Summary	
Animal operation Acres	0.9
#/Type Animal	Unknown
# of Landowners	1
Soil Type	346
Wetlands Present	No
Streams Present	No
Ditching Present	No
Distance to Surface Water	580'

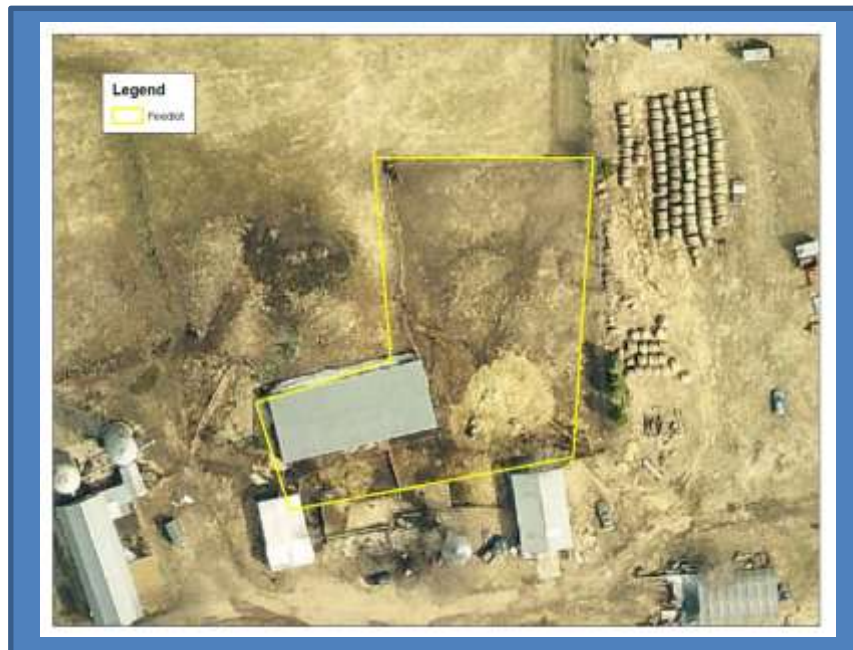
Rush Lake Watershed-Animal operation 22

This is a small animal operation of about 0.5 acres with a few horse and bovine animals. The animal operation is surrounded on two sides by road ditching, which drains the animal operation runoff to a series of drainage ditches.

Catchment Summary	
Animal operation Acres	0.6
#/Type Animal	1-10 Mixture
# of Landowners	1
Soil Type	292;204B;346
Wetlands Present	No
Streams Present	No
Ditching Present	Yes
Distance to Surface Water	0'

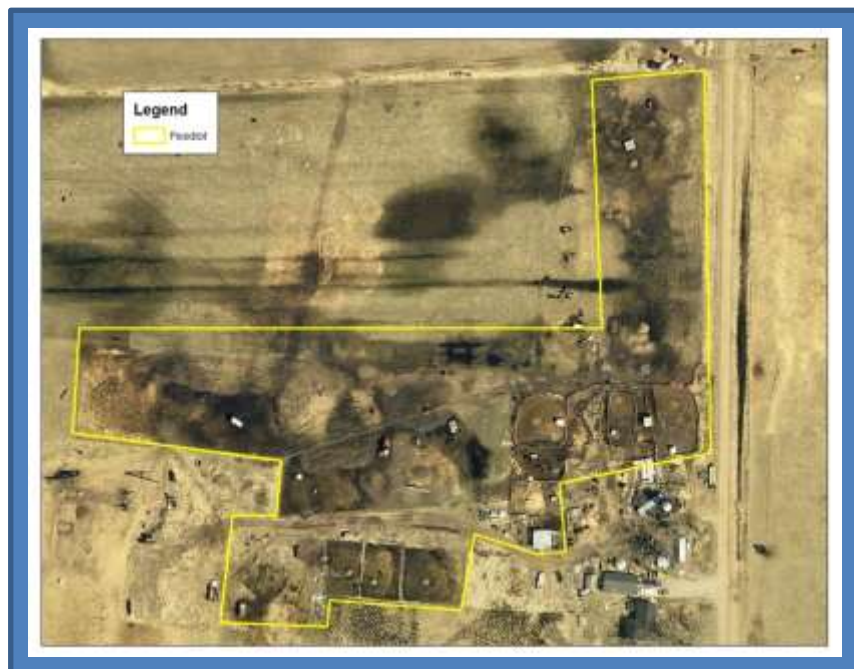
Rush Lake Watershed-Animal operation 91

This is a large animal operation of about 7 acres with bovine animals. The animal operation drains to a drainage ditch.

Catchment Summary	
Animal operation Acres	6.8
#/Type Animal	101-250 Bovine
# of Landowners	1
Soil Type	292;346
Wetlands Present	No
Streams Present	No
Ditching Present	No
MPCA Registered?	Yes
Distance to Surface Water	540'

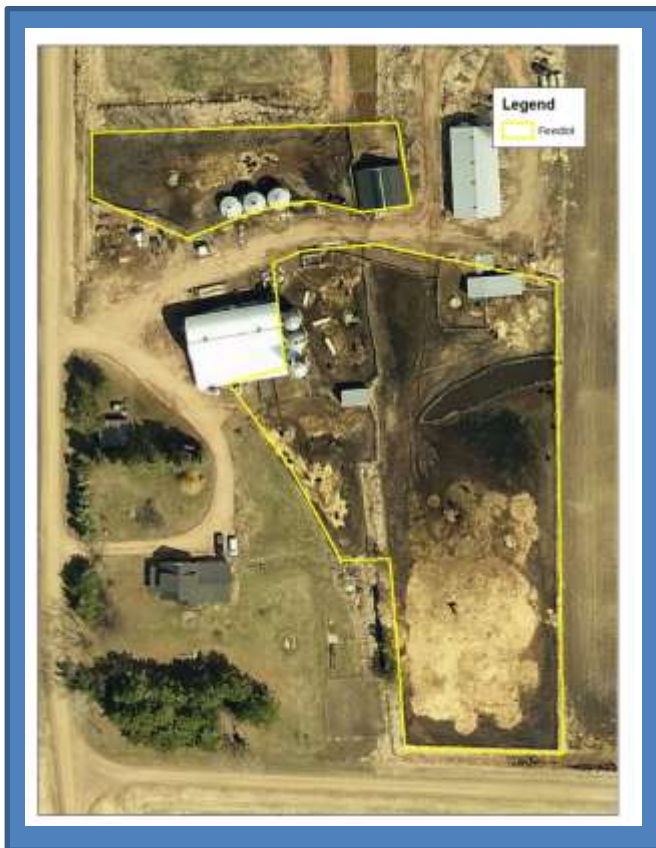
Rush Lake Watershed-Animal operation 236

This is an animal operation of about 3 acres with bovine animals. The animal operation drains to drainage ditches.

Catchment Summary	
Animal operation Acres	2.6
#/Type Animal	11-100 Bovine
# of Landowners	1
Soil Type	292;346
Wetlands Present	No
Streams Present	No
Ditching Present	Yes
Distance to Surface Water	0'

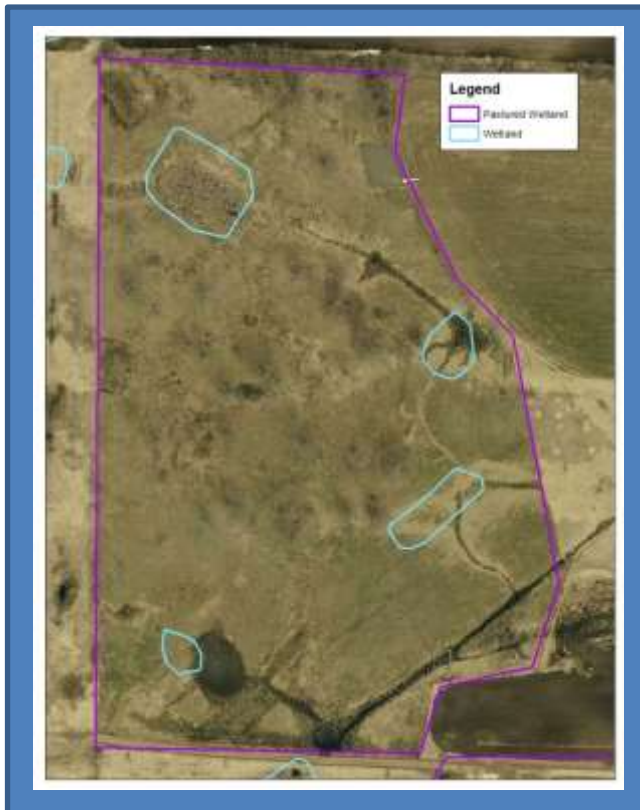
This is a pasture of about 22 acres. Within this pasture are four small wetlands. Each has been drained or partially drained with ditching to the nearby stream. This stream also runs through the pasture and empties into Rush Lake.

Catchment Summary	
Pasture Acres	22.0
#/Type Animal	250+ Bovine
# of Landowners	1
Soil Type	346;75
NWI Wetlands Present	Yes
Streams Present	Yes
Ditching Present	Yes

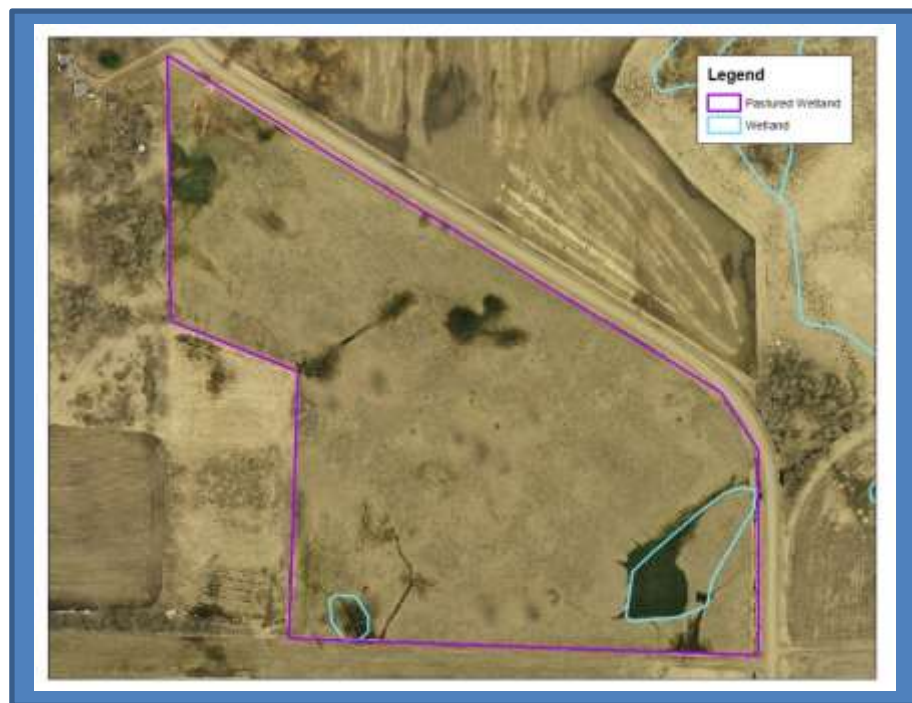
Rush Lake Watershed-Pasture 225

This is a pasture of about 20 acres. Within this pasture are several small wetlands. Each has been drained or partially drained with ditching to the nearby stream. The stream also runs through the pasture and empties into Rush Lake.

Catchment Summary	
Pasture Acres	20.3
#/Type Animal	250+ Bovine
# of Landowners	2
Soil Type	346;75
NWI Wetlands Present	Yes
Streams Present	Yes
Ditching Present	Yes

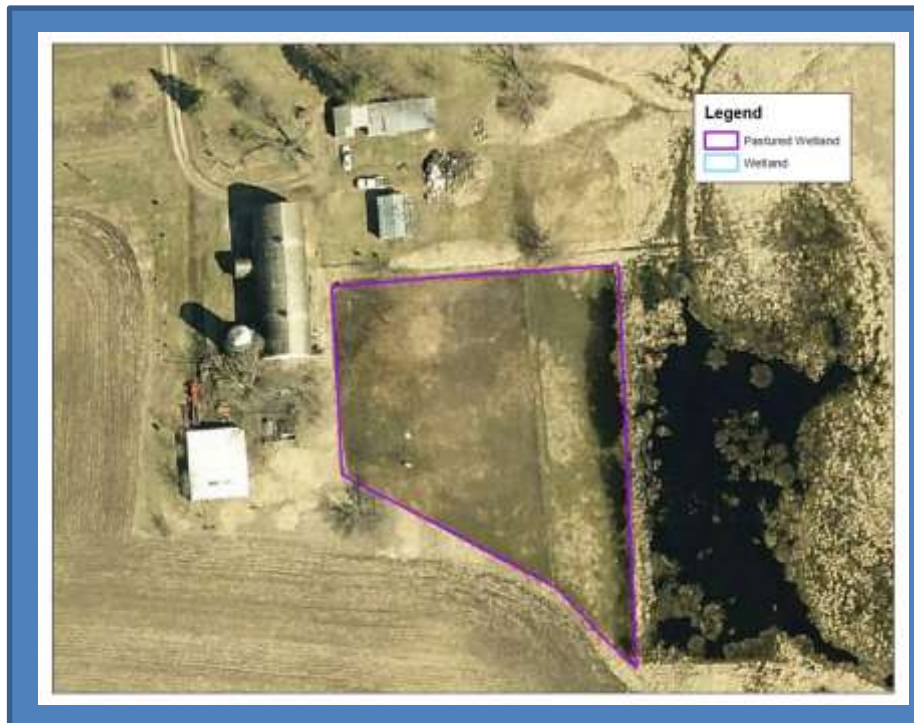
This is a pasture of about 1 acre. This pasture borders a large open-water wetland that has been ditched.

Catchment Summary	
Pasture Acres	0.9
#/Type Animal	0-10 Horse
# of Landowners	1
Soil Type	346;75
NWI Wetlands Present	No
Streams Present	No
Ditching Present	Yes

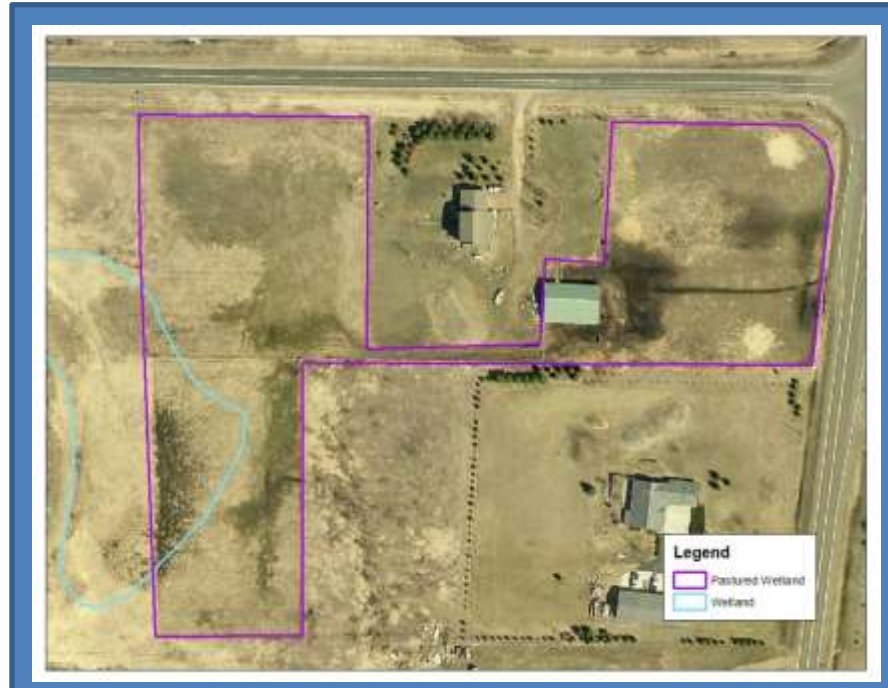
Rush Lake Watershed-Pasture 366 & 365

This is a pasture of about 6 acres. Within this pasture are four small wetlands. Each has been drained or partially drained with ditching to the nearby stream. This stream also runs through the pasture and empties into Rush Lake.

Catchment Summary	
Pasture Acres	5.8
#/Type Animal	0-10 Horse
# of Landowners	1
Soil Type	346;75;292
NWI Wetlands Present	Yes
Streams Present	No
Ditching Present	No

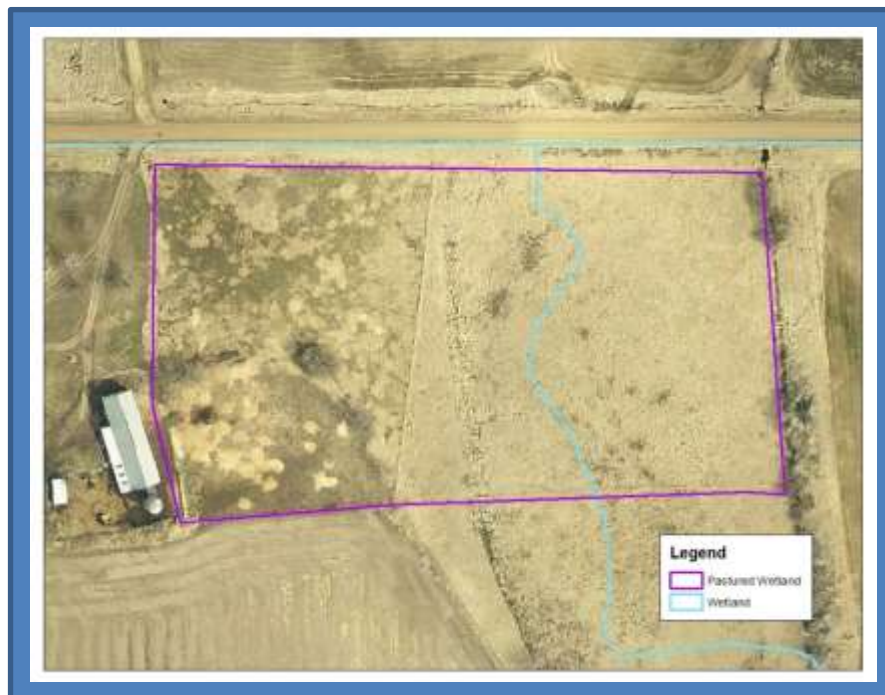
Rush Lake Watershed-Pasture 15

This is a pasture of about 8 acres. About half of this pasture is wetland. The wetland is ditched and eventually outlets to Rush Lake.

Catchment Summary	
Pasture Acres	7.8
#/Type Animal	0-10 Bovine
# of Landowners	1
Soil Type	544;75
NWI Wetlands Present	Yes
Streams Present	No
Ditching Present	Yes

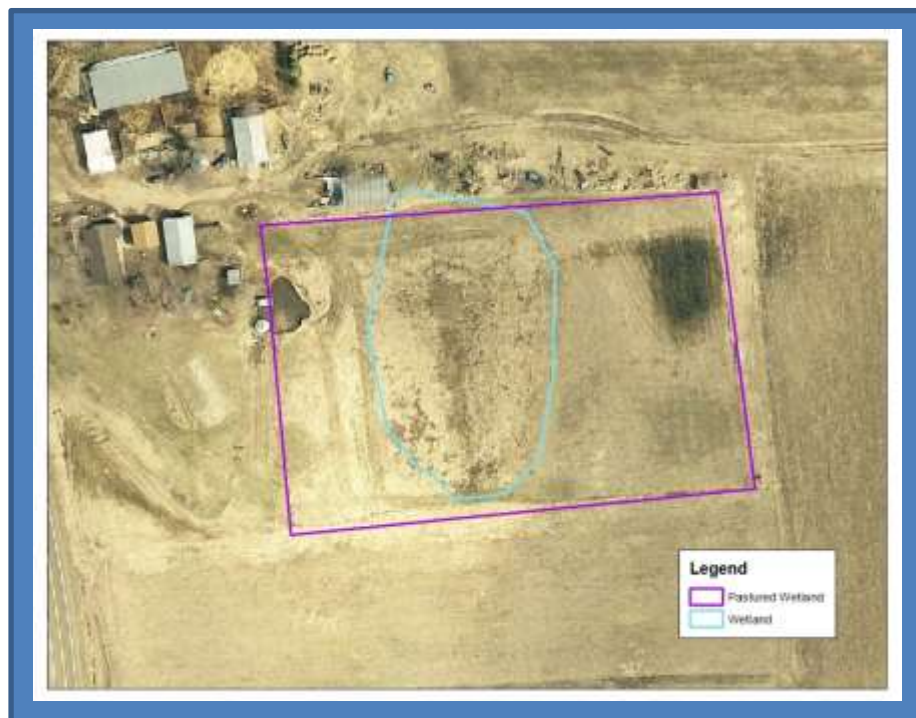
Rush Lake Watershed-Pasture 23

This is a pasture of about 5 acres. Within this pasture is a wetland that is wet most of the time. When this wetland overflows, it runs to the west, through a culvert under the road, and contributes to a large gully in the neighboring field. This pasture contains both horses and bovines.

Catchment Summary	
Pasture Acres	5.0
#/Type Animal	0-10 Mixed
# of Landowners	1
Soil Type	346;292;204B
NWI Wetlands Present	Yes
Streams Present	No
Ditching Present	No
