DIBBLE WATER & SEDIMENT CONTROL BASIN

AGRICULTURAL BEST MANAGEMENT PRACTICES

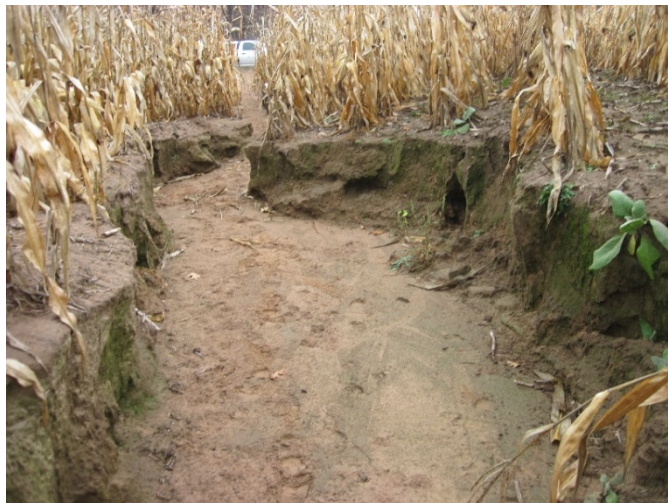
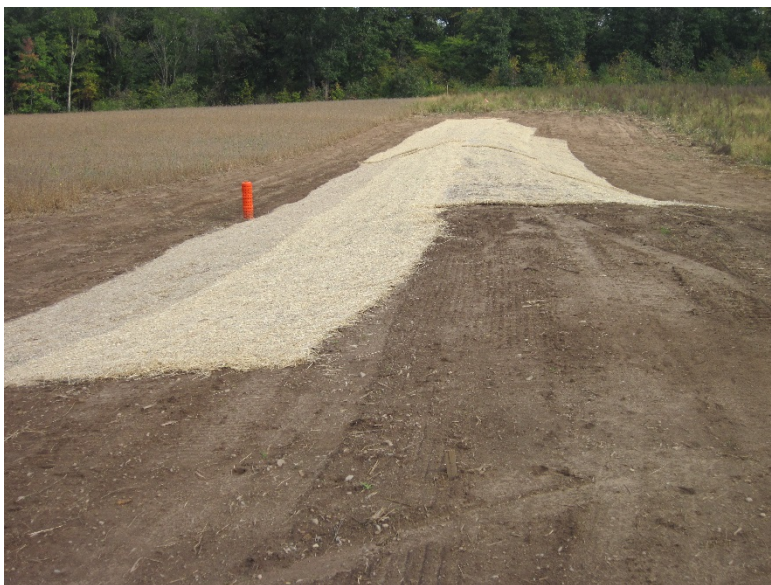
Tom Dibble's farm includes a field at the top of the St. Croix River escarpment in the southern part of Chisago County. Runoff from the agricultural field was causing major erosion within the field itself, as well as on the steep slope of the escarpment. Large amounts of sediment were being washed off the field and ending up in the St. Croix River.

In 2015, Tom Dibble installed a water and sediment control basin to stabilize the erosion. A berm of soil was used to create a temporary ponding area to hold water back during a rain storm. A pipe was installed to slowly drain the ponded water so that the field will dry out within 1-2 days so crops are not damaged. The water will now slowly trickle out of the end of the pipe. With the reduced velocity of water, no erosion will occur at the pipe's outlet and the gully will no longer actively erode.
