# LAKE AVENUE DEAD END STREET PROJECT

## VEGETATED SWALE WITH ROCK CHECK DAMS

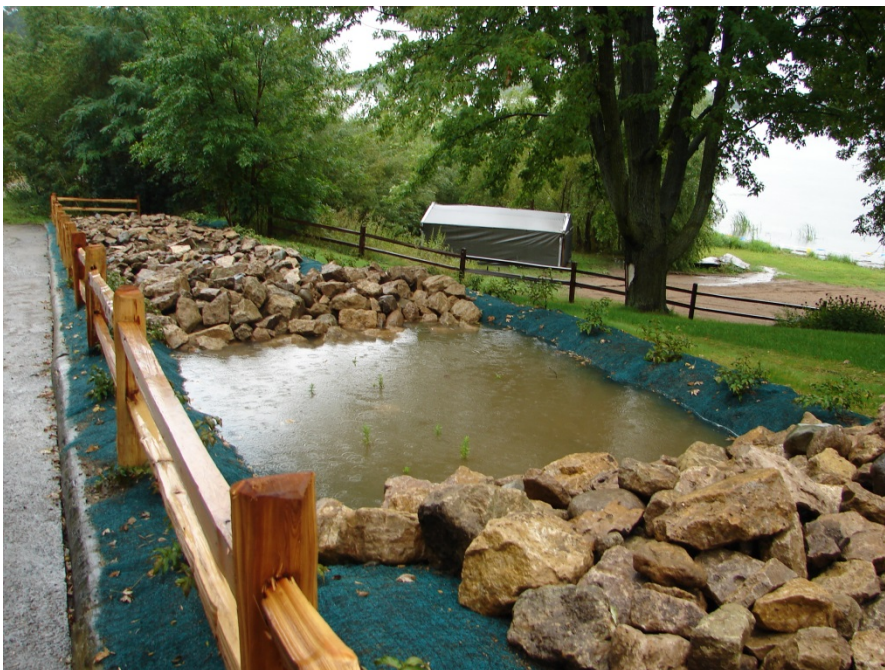
One half of the road was removed and replaced with a series of vegetated basins and rock check dams. The stormwater pipe was also daylighted early, so that the water enters the basins before reaching the lake. Water fills the basins and overflows through the rock to the next lower basin. The water in the basins can soak into the ground, where it is filtered. Winter access to the lake is maintained in a single-lane drive.
