LOREN'S PARK—CENTER CITY

VEGETATED SWALE AND RAIN GARDEN

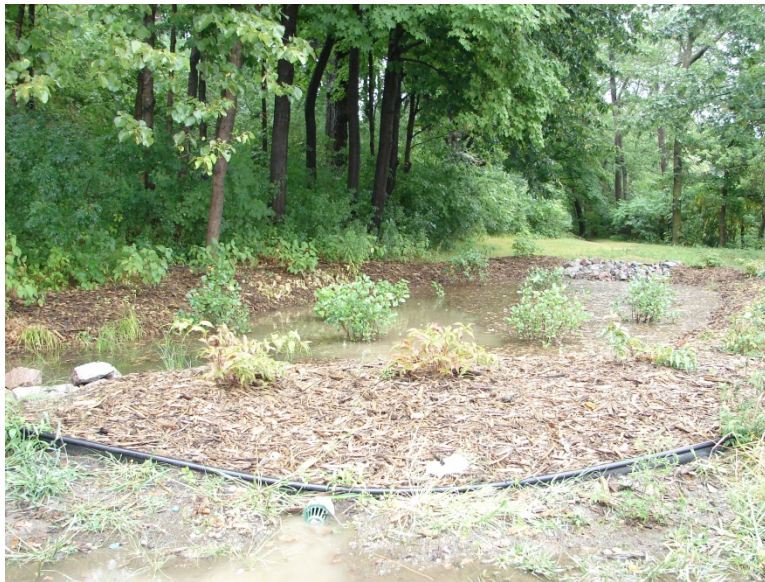
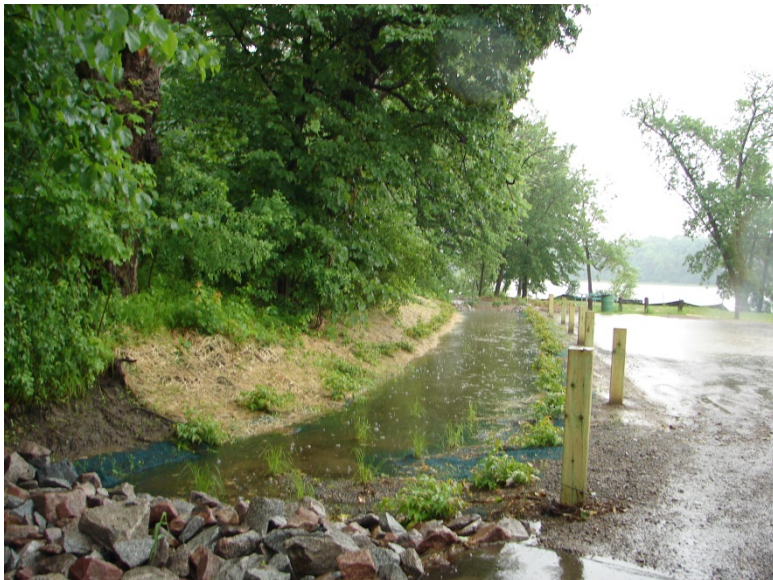
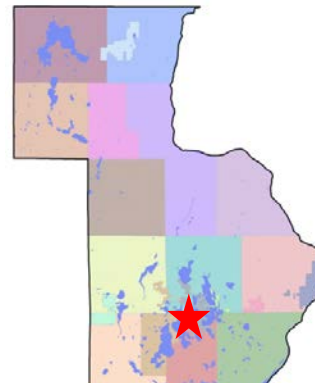
To correct the gully, the City of Center City paved the driveway and tipped it to the inside of the slope. The runoff collects along the inside curve of the road, where a curb guides it into a pretreatment chamber. The chamber collects leaves, twigs, and sediment. The filtered water then enters a vegetated swale. If the swale fills up, water overflows into a rain garden that is planted with native shrubs.
