# LINDEN STREET RECONSTRUCTION

## WATER QUALITY PROJECTS

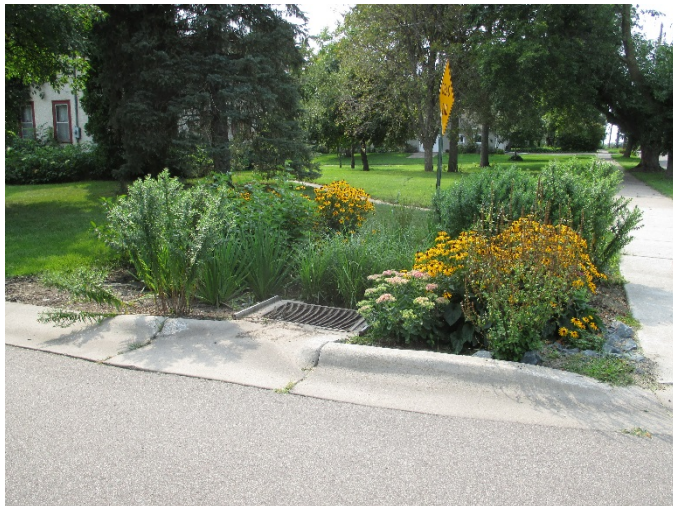
The City of Lindstrom partnered with the Chisago Soil & Water Conservation District to solve erosion problems that were occurring at the end of Linden Street, a dead-end road with a steep slope to the lake. This project has two curb cut rain gardens at the top of the hill, on either side of Linden Street. These

capture stormwater runoff from nearby roads before it runs down Linden Street.

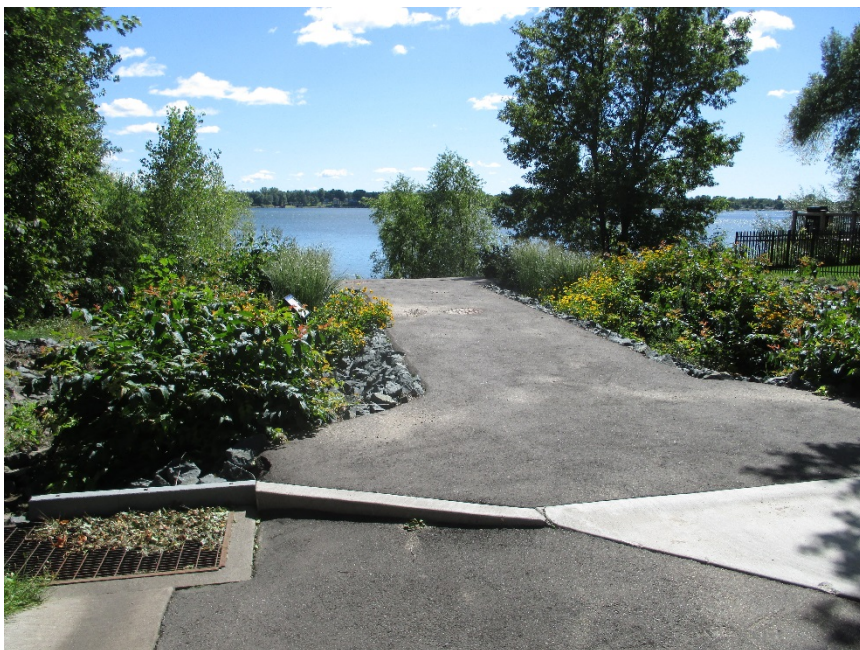
At the end of Linden Street are two more linear rain gardens. What you can't see is an underground sand/iron filter that removes phosphorus from the water. The phosphorus binds to the iron fillings and is kept out of South Lindstrom Lake. The large rock swales are emergency overflow for large storms that overwhelm the rain gardens and filter.
